THE RICHARD MORRIS HUNT FELLOWSHIP

**RICHARD MORRIS HUNT
FELLOWSHIP
1991**

Pierre-Antoine GATIER
Architecte en Chef des Monuments Historiques

The year 1991 marked the second annual exchange for the Richard Morris Hunt Fellowship between France and the United States. The Fellowship supports an exchange for historic preservation architects to facilitate a mutual understanding of preservation activities between the countries. Sponsored by the Friends of Vieilles Maisons Francaises and the American Architectural Foundation, the Fellowship provides a grant and programmed activities for the selected Fellow. Each year the Fellows alternate, and the 1991 exchange sponsored a French candidate who embarked on a study tour of the United States. The six month program began in July of 1991 and was completed in December of the same year.

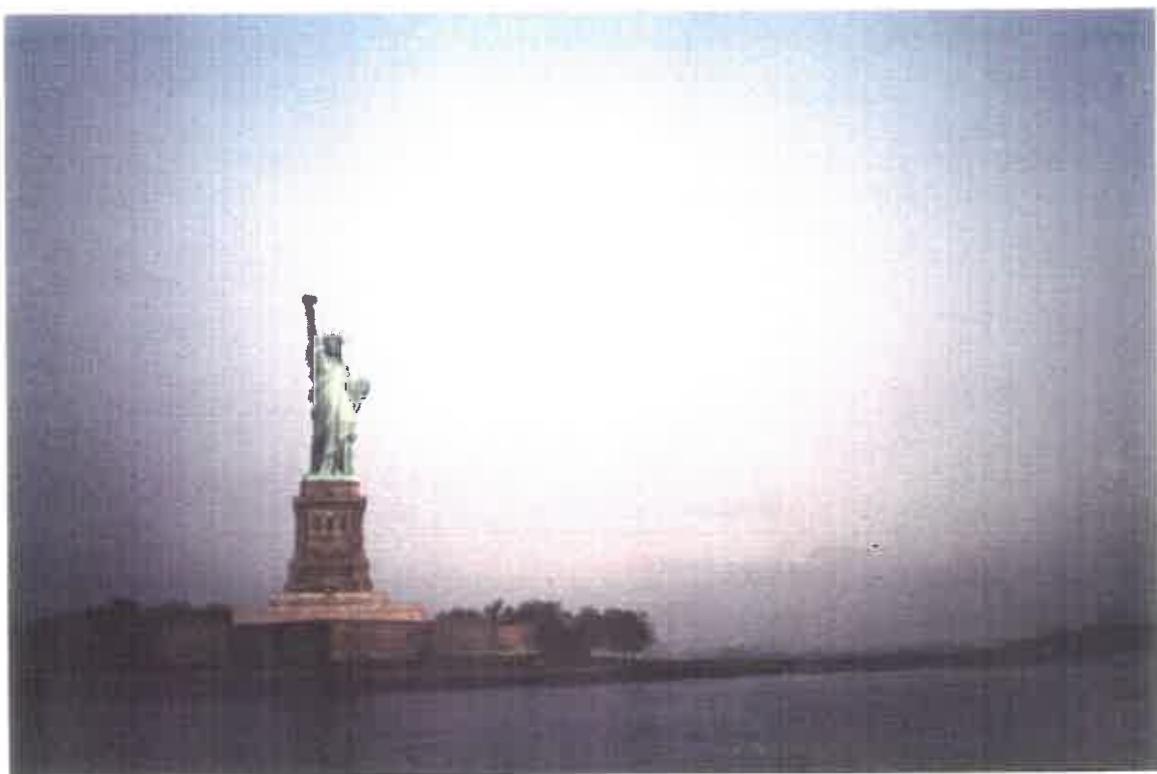
New York, N. Y.

Bartholdi's copper sculpture, over Eiffel's (the body) and Viollet le Duc's (the head) inside structure, over Richard Morris Hunt's pedestal.

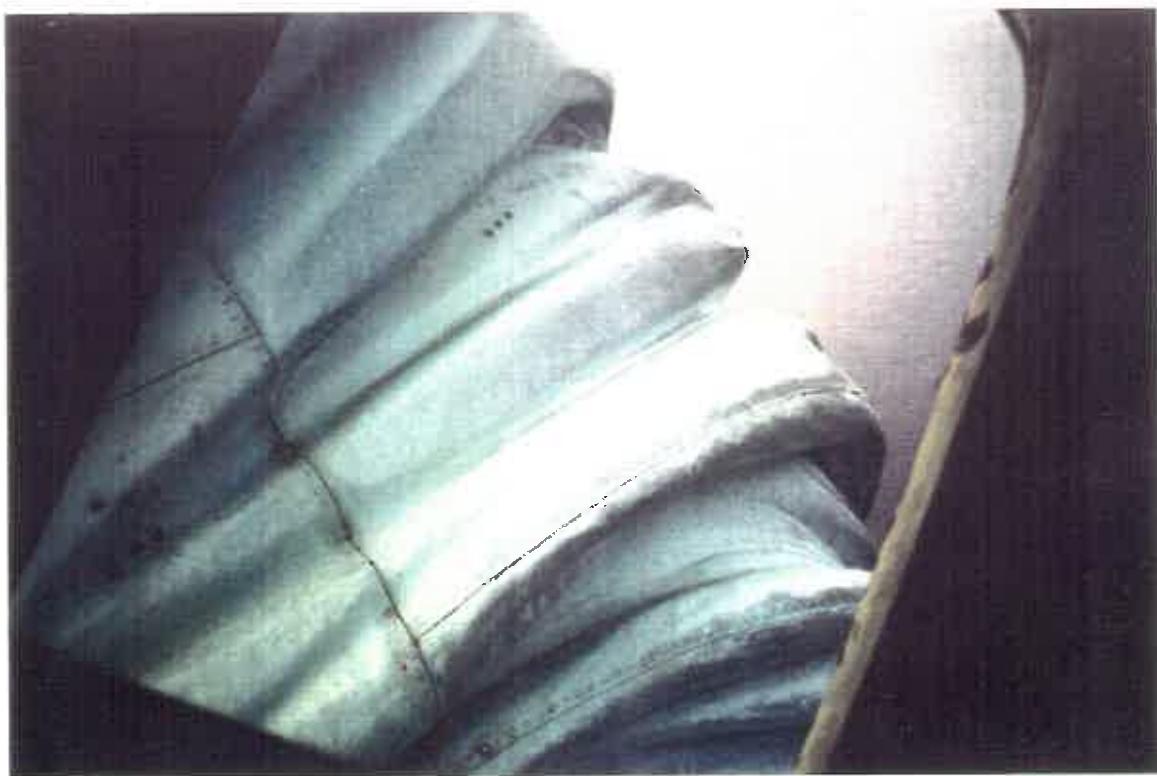
Superposed sheets of copper with rivets.

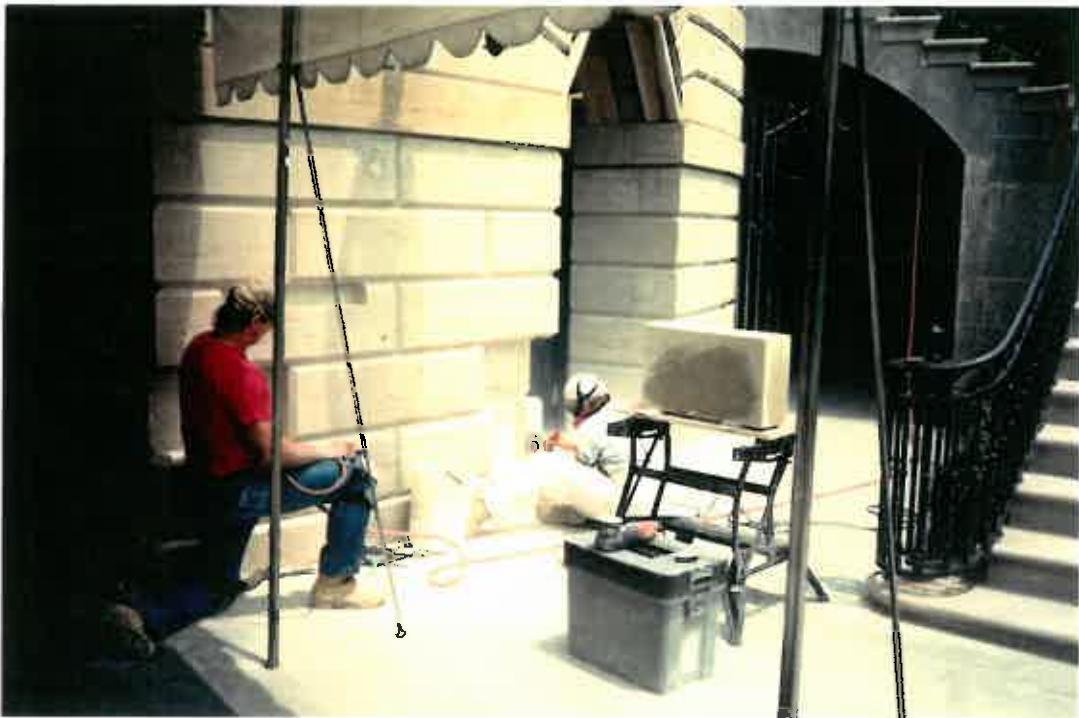
THE WHITE HOUSE
Washington, D.C.

Restoration of the facade by the stonecutters
(use of mechanical tools)

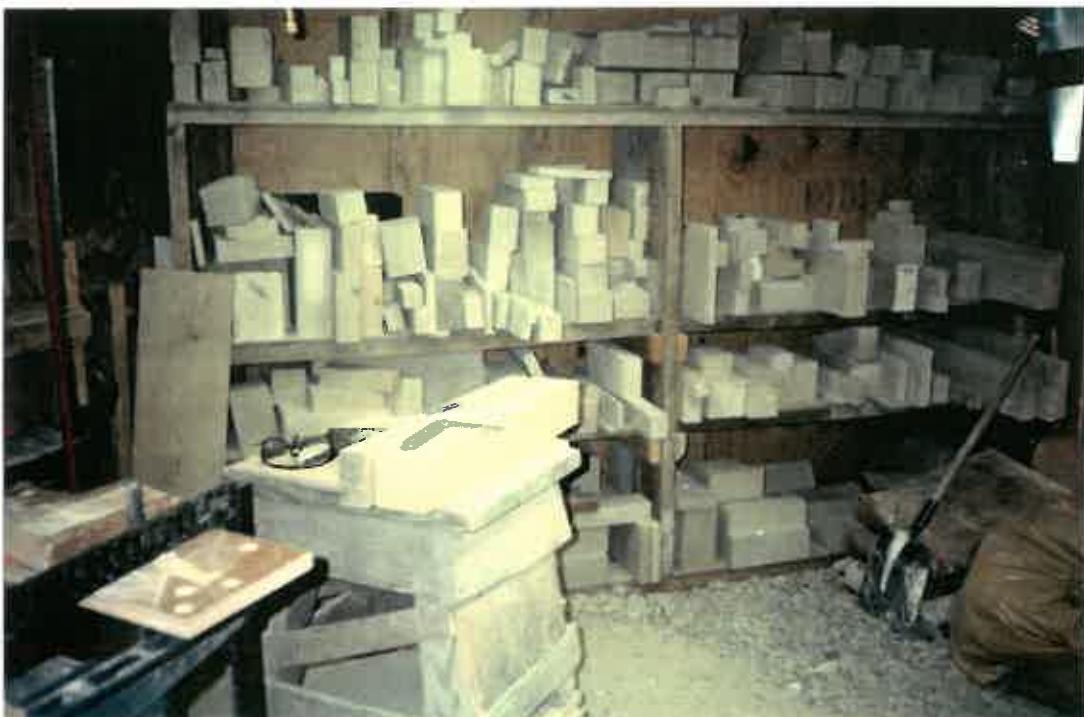
Stonecutters' workshop, collection of limestone Dutchman,
from the Acquia Creek quarry

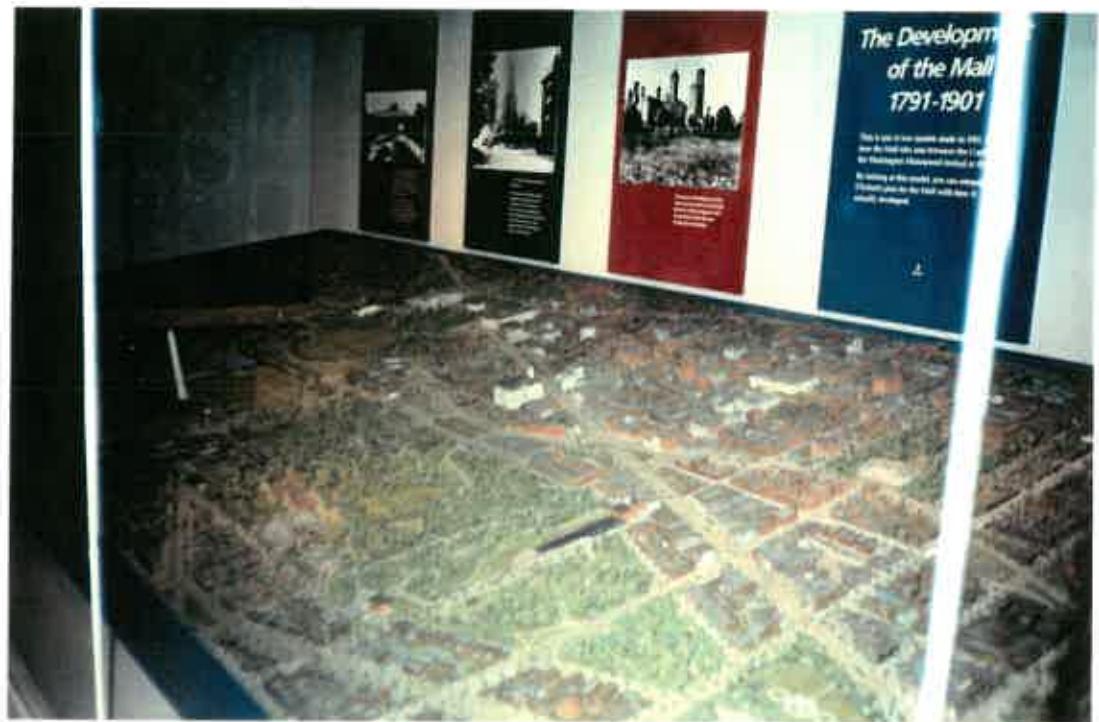
1901 models created by the MacMillan commission for the redevelopment of D.C. showing the city at the end of the XIXth century.

In 1901, in commemoration of Washington's centennial, the McMillan Commission was organized to create a revised plan for the central area of the city. Members of the Commission were leading architects and planners who had most recently been responsible for the successful and innovative Columbia Exhibition in Chicago. Members of the Commission included the architect and planner, Daniel H. Burnham; architect, Charles F. McKim, and landscape architect, Fredrick Law Olmstead. While the plan for Washington gave form to the ideals of the City Beautiful movement, it maintained, as well, the classic forms of L'Enfant's earlier planning efforts. The McMillan plan called for modification of the gardens of the mall, replacing Andrew Jackson Downing's curved allées with straight ones designed as framing devices to the monumental buildings (See also, TOUR: Olmstead Park). The plan proposed a formal "federal triangle" area, south of Pennsylvania Avenue and north of the Mall, in which a block of federal buildings would be located. The scheme envisioned a block of low, white federal buildings, unencumbered by private enterprise. It was in reaction to this scheme that the proposal was made to demolish the Old Post Office Building, mentioned earlier (See also, TOUR: The Old Post Office Building). It is notable that the McMillan Commission plan would continue to be a guiding force in the development of Washington's central area for over three decades, and continues to influence architecture and urban planning today.

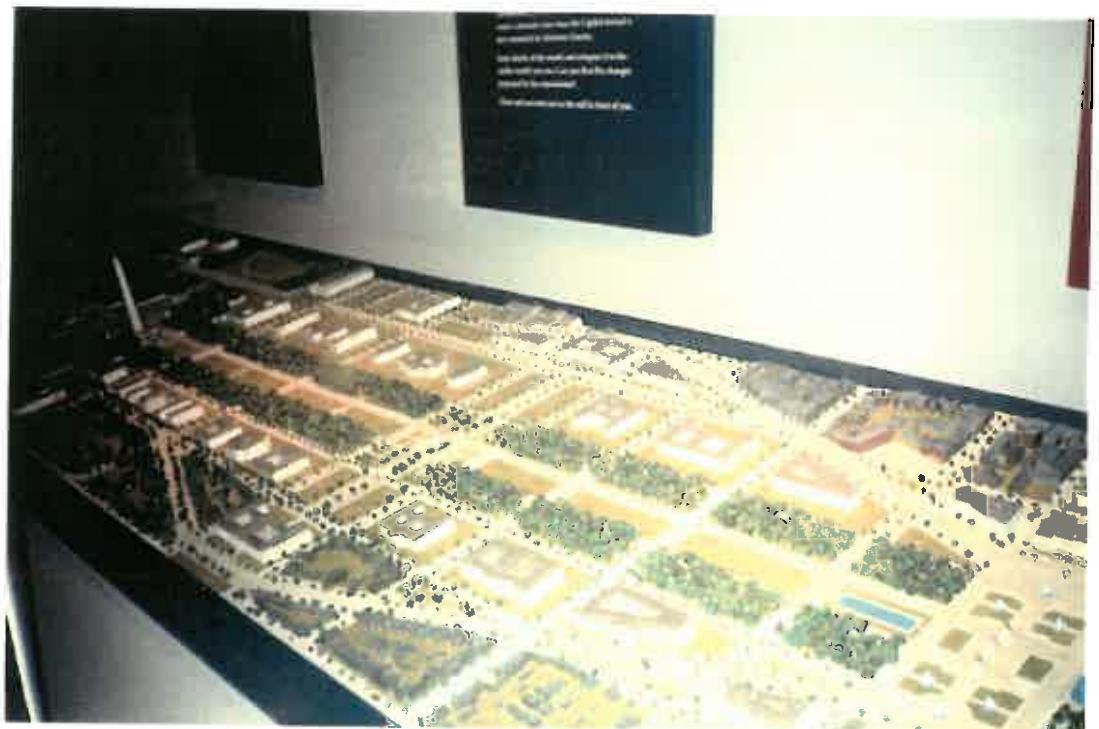
1901 MacMillan commission's project with the modification of the Mall and the creation of the Federal triangle (demolition of the Old Post Office)

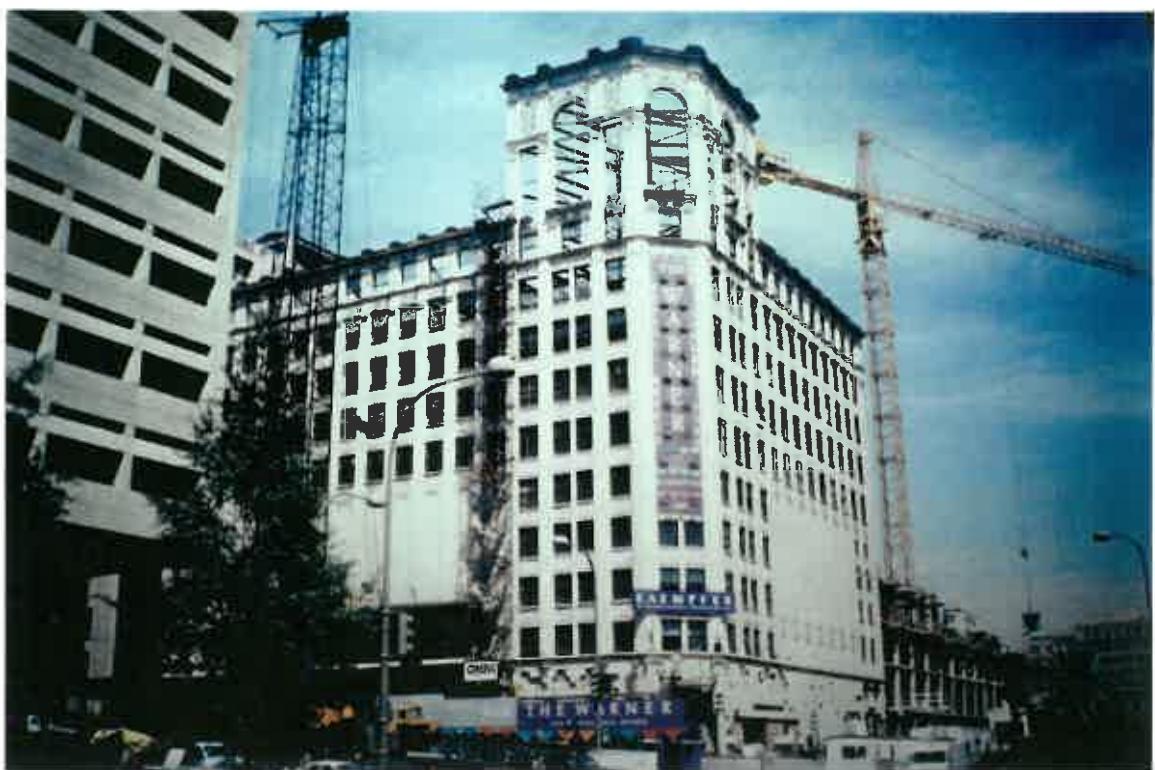
THE WARNER THEATRE
Washington D.C.

Facade preserved for a new office building to be created inside the old envelope.

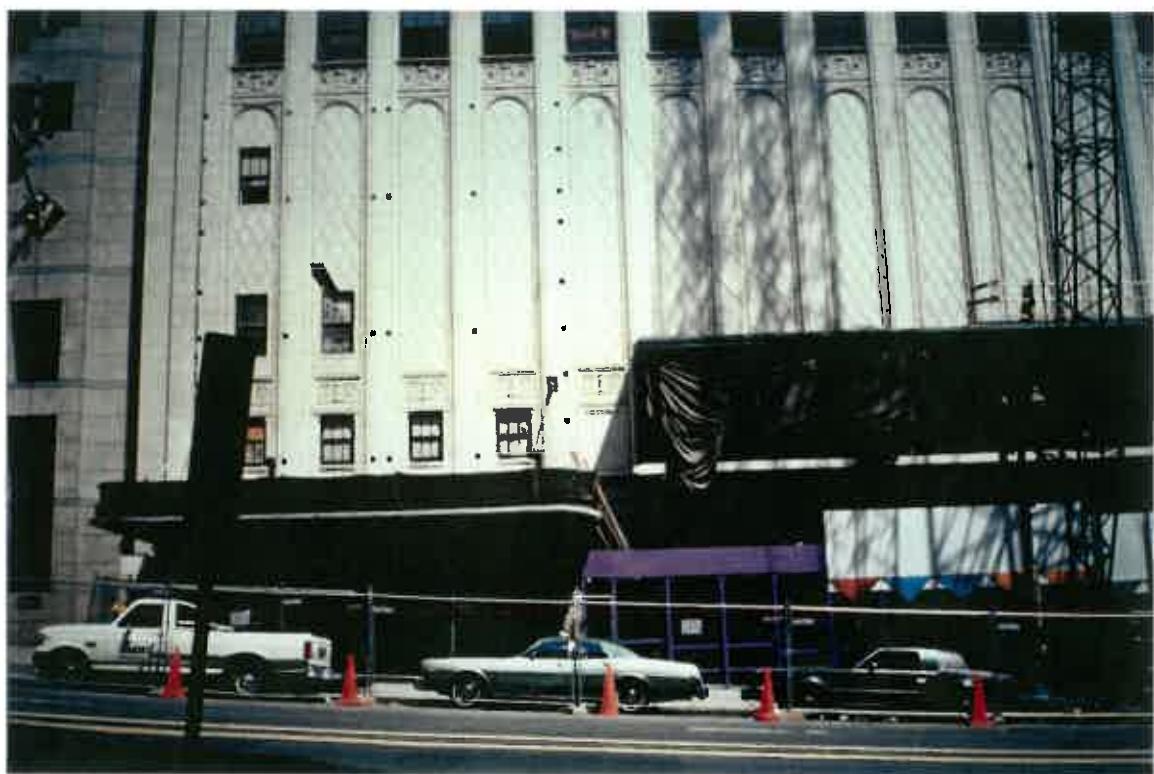
Buff glazed terra cotta veneer.

Judy Nelson, project architect for the Warner Theater, described several of the technical aspects of terra cotta restoration and replacement. Beginning with a survey of the condition of the building, the architects determine the exact restoration needs. They evaluate the condition of the tiles, the anchors tying the curtain wall to the underlying brick structure, and the brick bearing wall itself. Deteriorated conditions in the bearing wall can result in technical problems with the tile facade, so identifying and correcting such problems is essential. Likewise, the metal anchors which connect the tiles to the bearing wall will often rust, thereby weakening the connection. Finally, tiles on the facade will exhibit various stages of deterioration, and must be dealt with categorically.

The restoration of the Warner Theater involves the replacement of metal anchors and the securing or replacement of individual terra cotta tiles. The decision was made to replace

rusting metal anchors for the entire cornice area. In addition, anchors for tiles on the facade are being replaced piece by piece as determined necessary by the initial survey. The condition of individual tiles is variable and several alternatives are available to the architects for restoration and replacement. Deteriorated conditions range from loose pieces to cracked tiles, and those in need of full replacement. Loose pieces are reattached with dowels, cracked tiles are injected with an epoxy to secure them, and deteriorated or missing tiles are replaced. This project required terra cotta replacement tiles in three colors, white, buff or beige, and pink, and in two finishes, matte and high gloss.

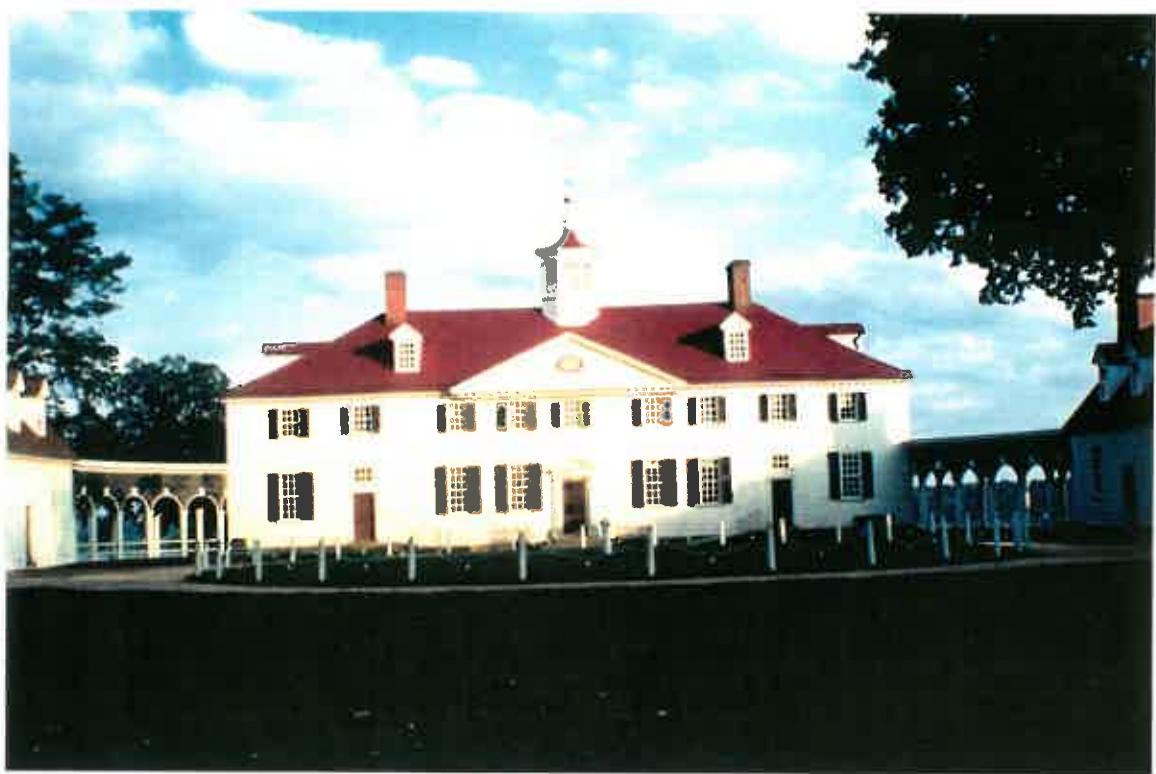
MOUNT VERNON
Virginia

The mansion house and the service buildings seen from the lawn, covered with the "spanish brown" shingle roof according to the 1793 Washington's painting project.

The buildings at Mount Vernon are 18th century structures that were constructed of building materials common to the colonial period. As at Monticello and with similar buildings in Georgetown, certain wooden elements of these structures were embellished with sand painting. The wood, a local yellow pine, was covered with three coats of white paint over which white sand was cast to achieve the effect of sandstone. Interestingly, this occurs at Mount Vernon only on the mansion house facade and on the facades of the auxiliary buildings visible from the mansion house. A similar notion occurs with the roofing materials, where wooden, originally bald cypress, shakes were painted "Spanish brown" to resemble Spanish tiles. Style even in Colonial times is ephemeral, however, as it has been learned that the flanking auxiliary structures originally had roofs of grey-blue resembling slate. In 1793, when the grey-blue faded, all was colored "Spanish brown" to match the roof of the mansion house.

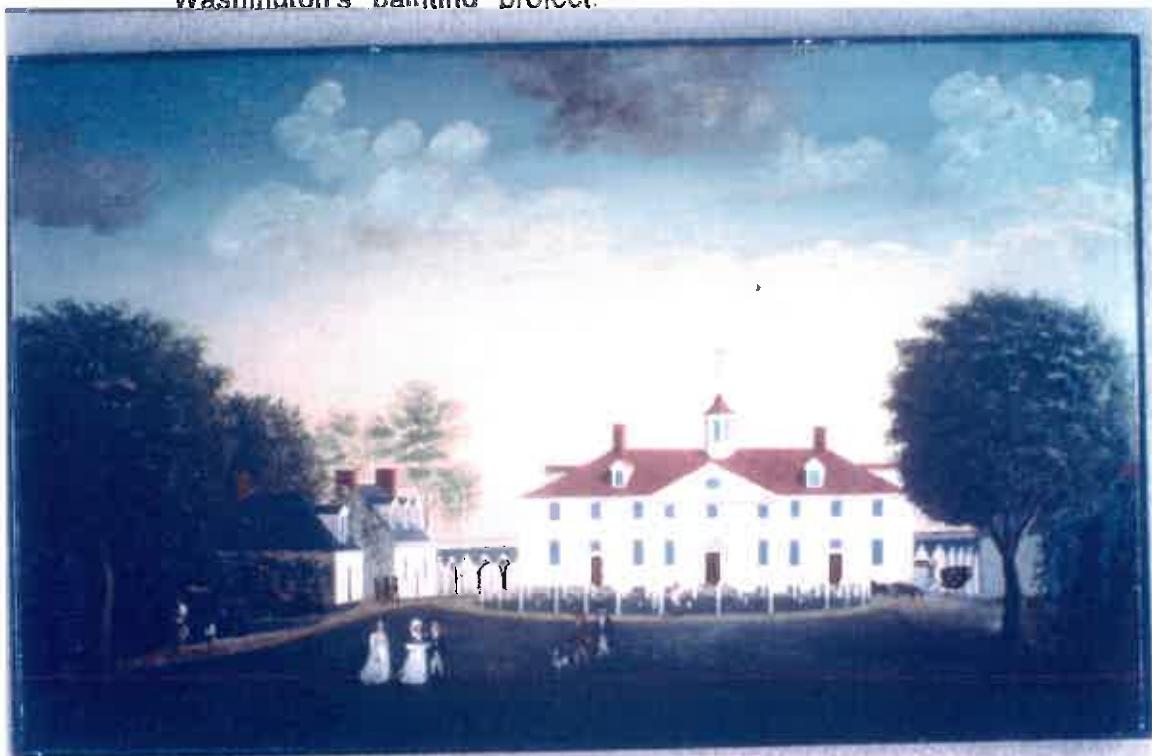
Wiew of the plantation with the service buildings covered with blue shingle roof (1792) before the colour modification.

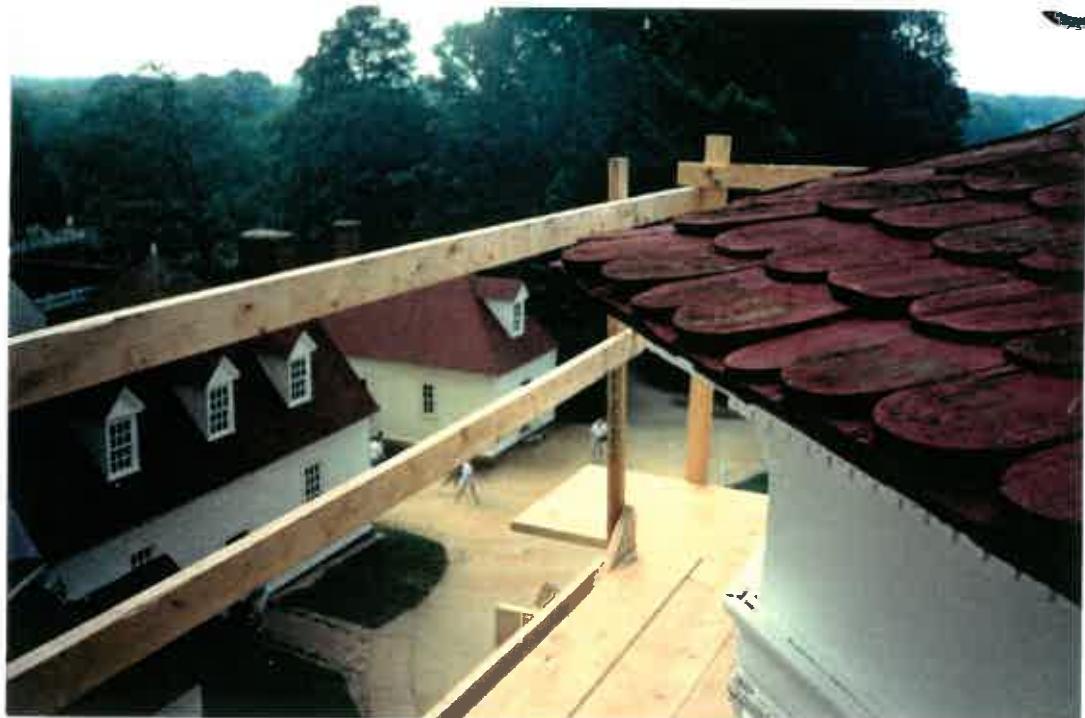
MOUNT VERNON
Virginia

Service buildings from the plantation surrounding the mansion house.

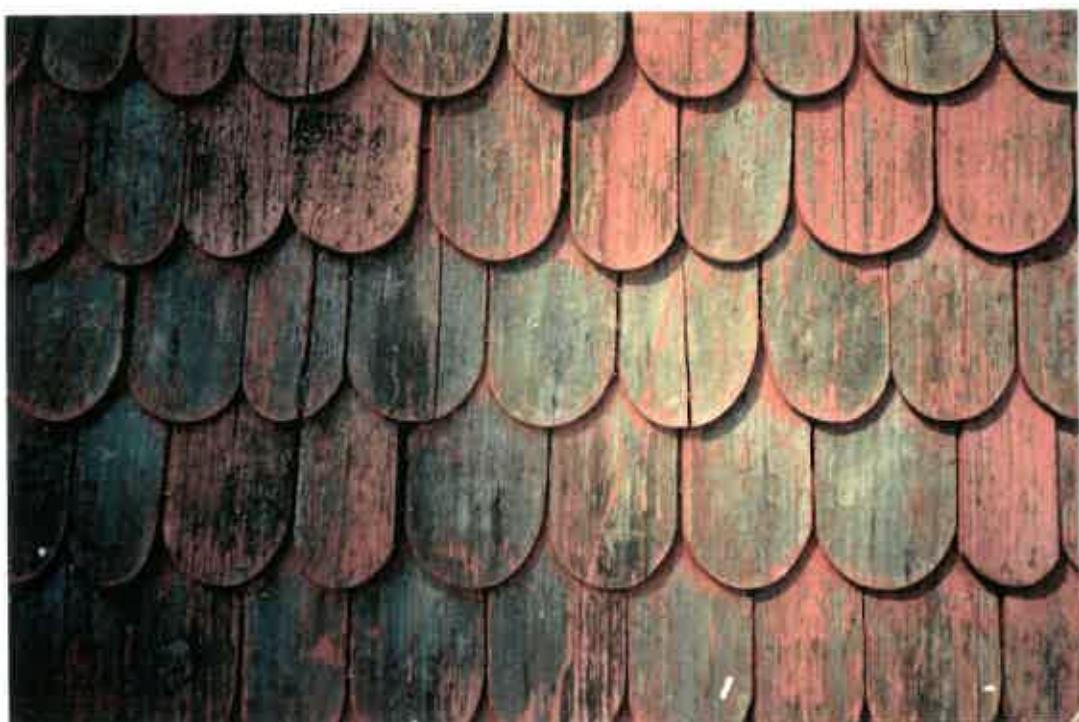
Shingle roof of the mansion house, using red cedar elements as a substitute material to the original bald cypress one, no more available.
Painted in "spanish brown" colour.

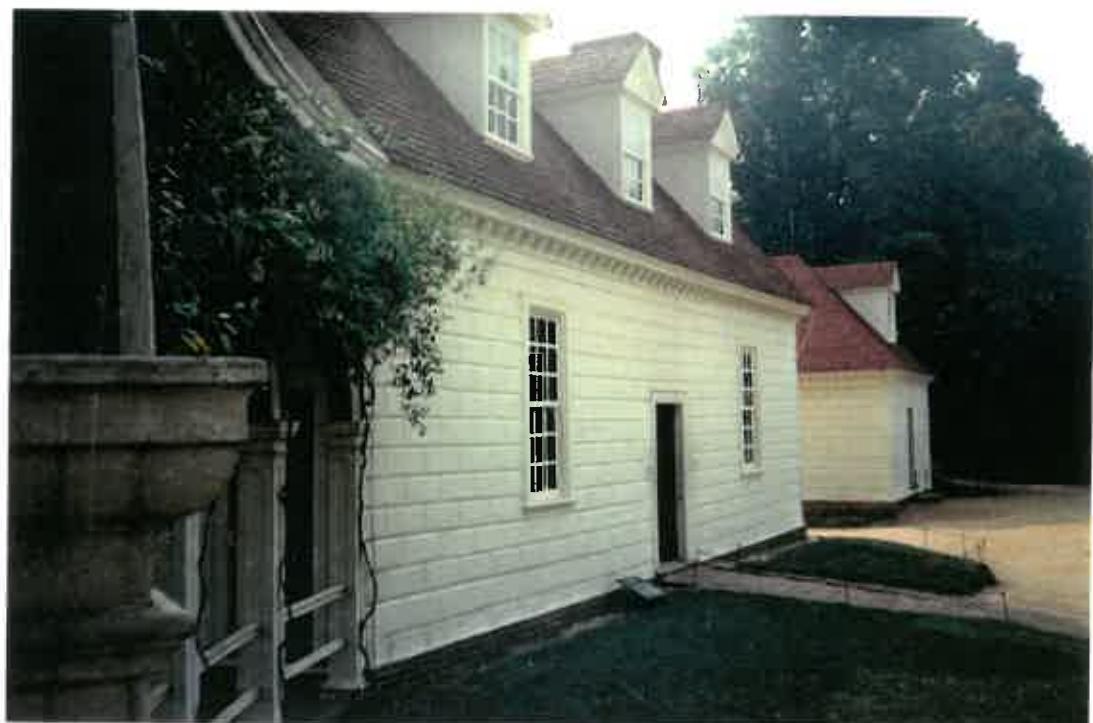
MOUNT VERNON
Virginia

Service building with rusticated wood siding (yellow pine)
and sand white painting as a substitute to a stone facade.

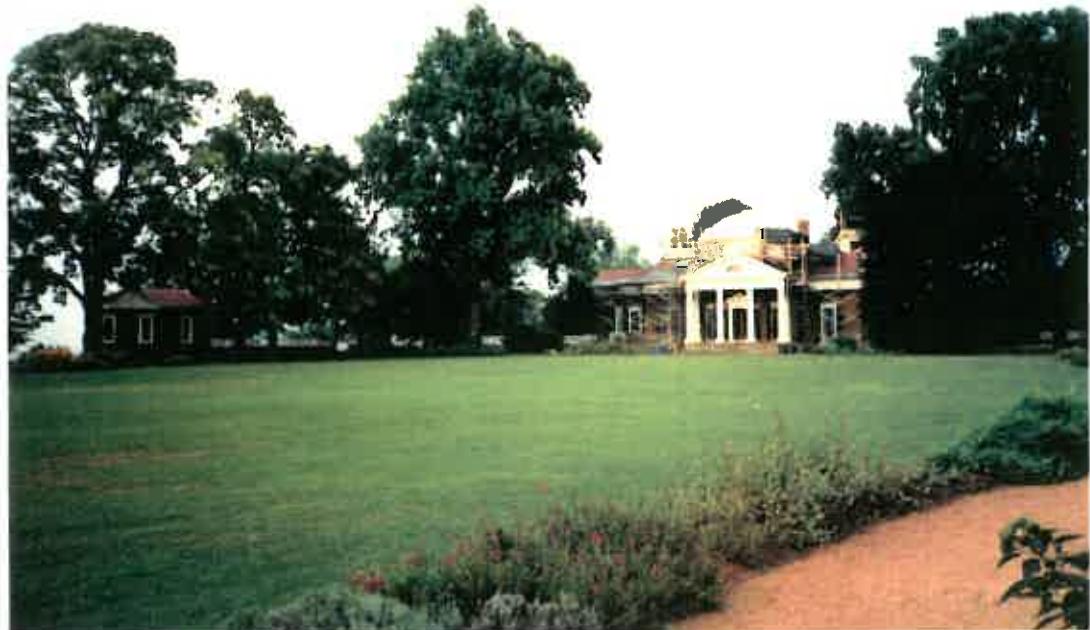
MONTICELLO
Virginia

Mansion House under repare (Restauration of the roof)
View from the lawn with the serpentine path

The roof of Monticello is a unique example of Jefferson's inventive architecture. The dome is a timber framework construction, bearing on a wrought iron base and covered with cast lead sheathed in wooden shingles. Jefferson replaced the wooden shingles with tin shingles in 1820 (See also, HABS, Construction Techniques at Monticello). The roof that extends out over the wings is constructed of tin plates in a "zig-zag" fashion, an idea perhaps borrowed from the tuiles canal roofing used on flat roofs in Europe. The architecture of the roof clearly reveals Jefferson's penchant for innovation where he employed classic construction techniques reinterpreted through the use of new industrial materials. To my thinking, this period in American architecture, exemplified by Jefferson's Monticello, marks the first step in modern architecture. The substitution of materials that was practiced by the laymen-architects of 18th century America had in many ways opened the door for 19th century technological substitutions.

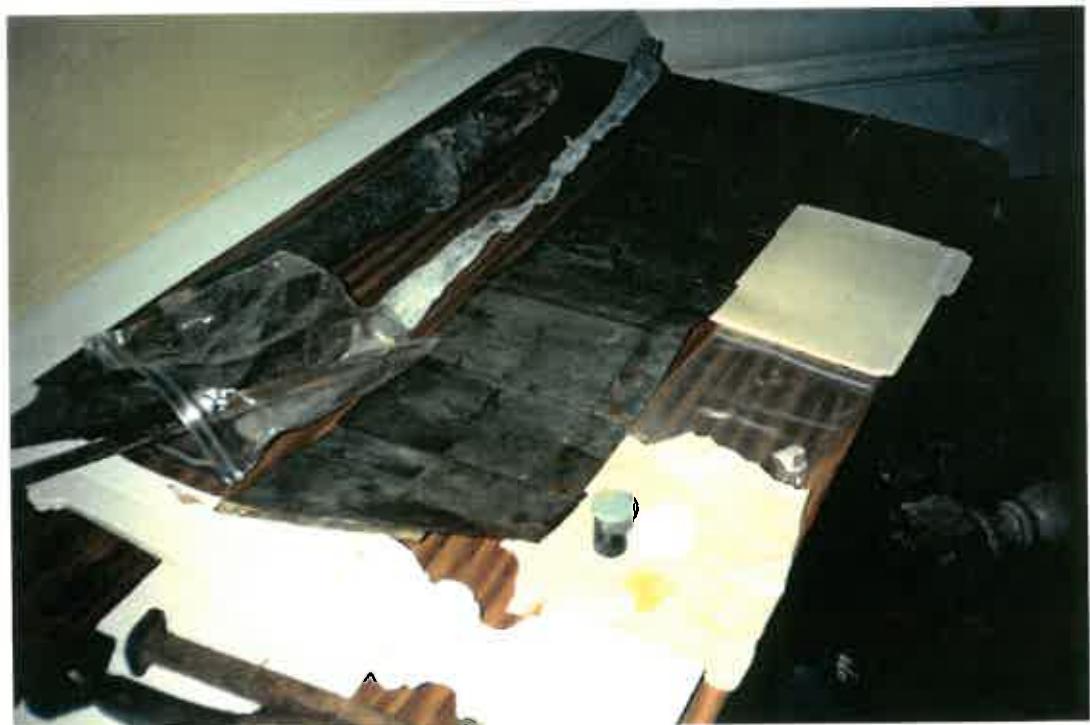
Collection of artefacts. Elements from the tinplate roofing materials
from the cuppola, built with a "Philibert Delorme" timber structure,
known through X. Ray Studies

The choice of materials for restoration remains faithful to the tin coated plates that were originally used, however, a new technique is being employed to fasten the plates together. Rather than nail the plates as Jefferson originally specified, a system of clips is being installed that will minimize punctures through the metal covering, thereby reducing the incident of water damage to the structure. It is my belief that the 18th century construction techniques at Monticello have become a part of the historic fabric of the property, and that every effort should be made to preserve them as they were originally employed.

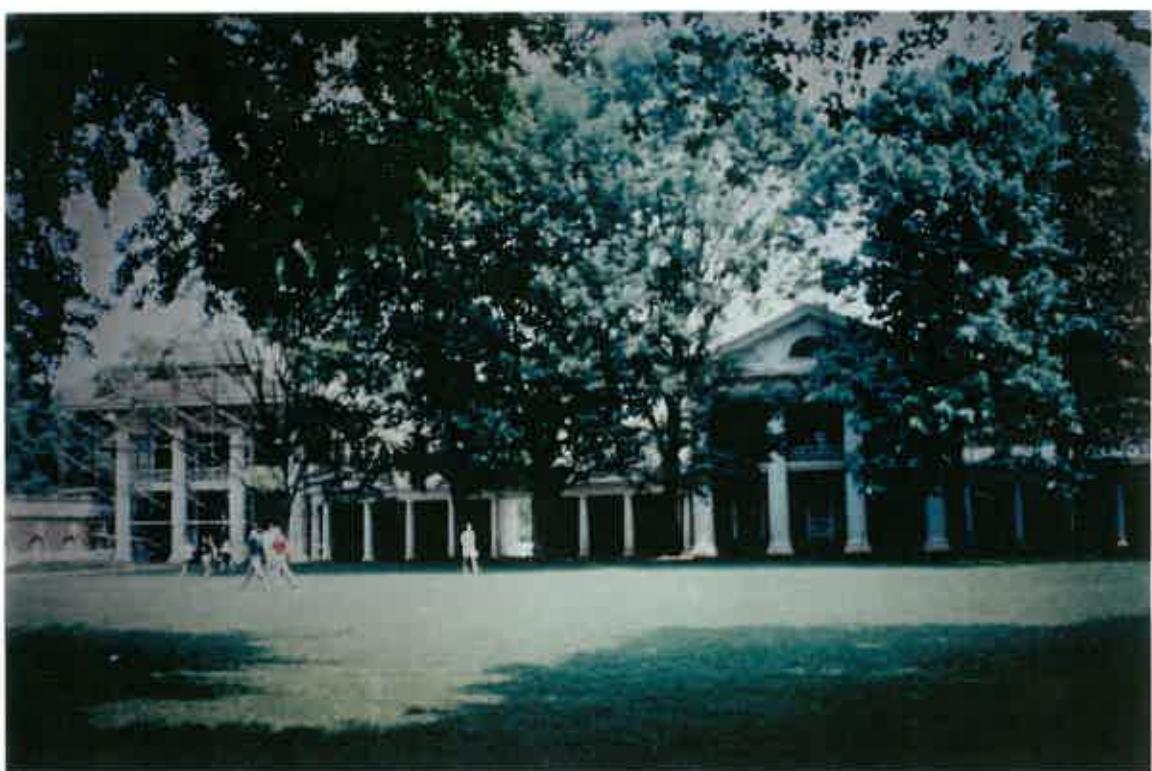
The Jefferson's Academical Village (1817-1826).
Restoration of a pavillon facing the lawn.

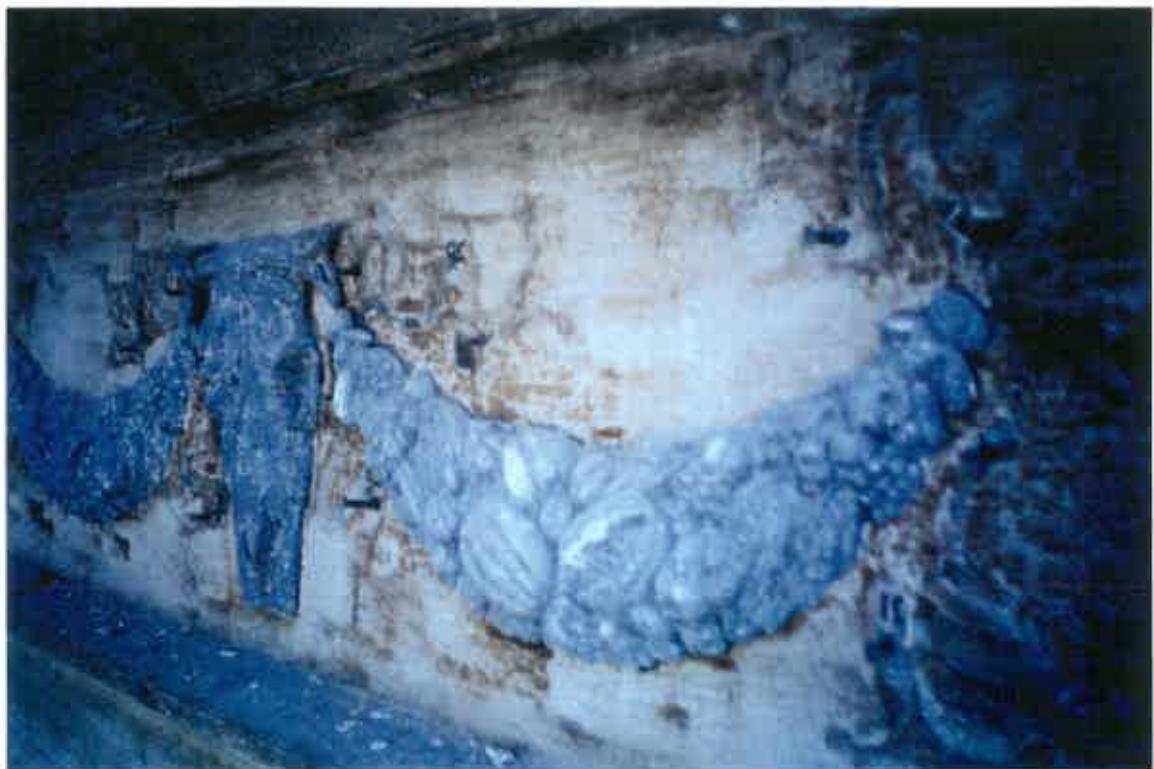
Decoration of the wooden cornice showing after the paint removal
screwed cast lead garments.

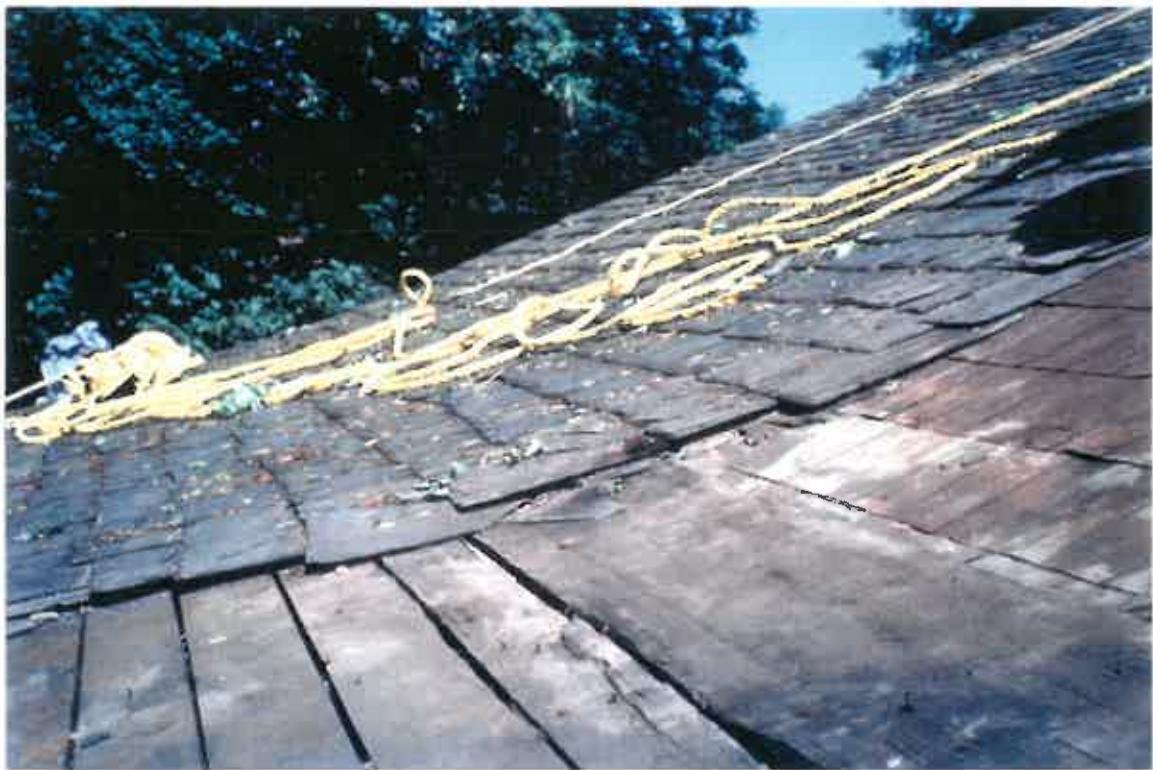
Removal of the slate roof showing the original Jefferson's tinplate roof and the wood planking (photo by Murray Howard)

The restoration of the roof over the pavilions has raised the question of maintaining the integrity of construction techniques used for the original building. Prior to restoration, the original tin-plate roof had been covered over with slate, though the original had been maintained in most instances. Howard's restoration program calls for the preservation of the original tin-plate roof beneath a covering of plywood on top of which will be placed a "terne plate" roof. Terne plate is a stainless steel plate coated with an alloy of tin and lead in an imitation of the original tin coated, wrought iron plates. In respecting the original construction techniques, Howard has specified that the plates be nailed in place as originally executed. To alleviate the potential for water to seep through, a neoprene barrier has been installed beneath the terne plate roof to close the nail holes. In this manner, restoration will be conducted that maintains the integrity of the original structures and in turn provides an acceptable level of upgrade to minimize deterioration.

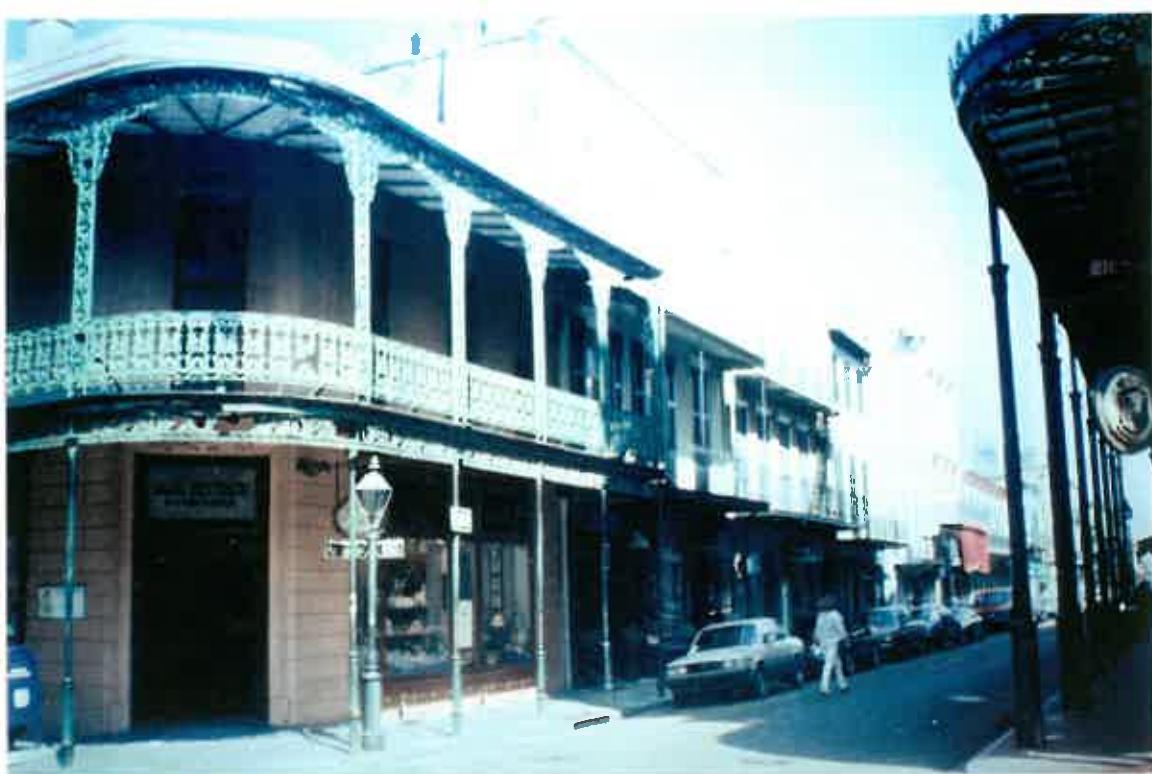
Cast iron galleries (St. Louis st. and Royal st.)

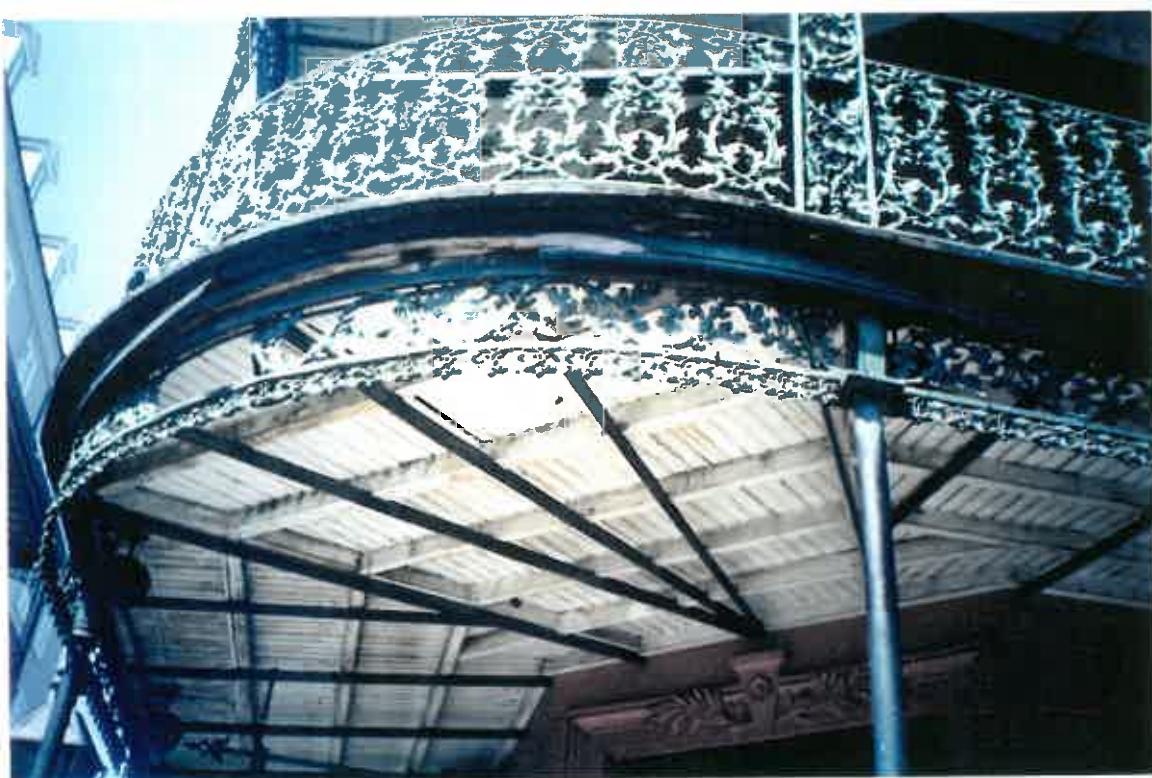
Wiew of the gallery , using cast iron ornated elements, and wrought iron radiating bars to sustain the wood beams and deck.

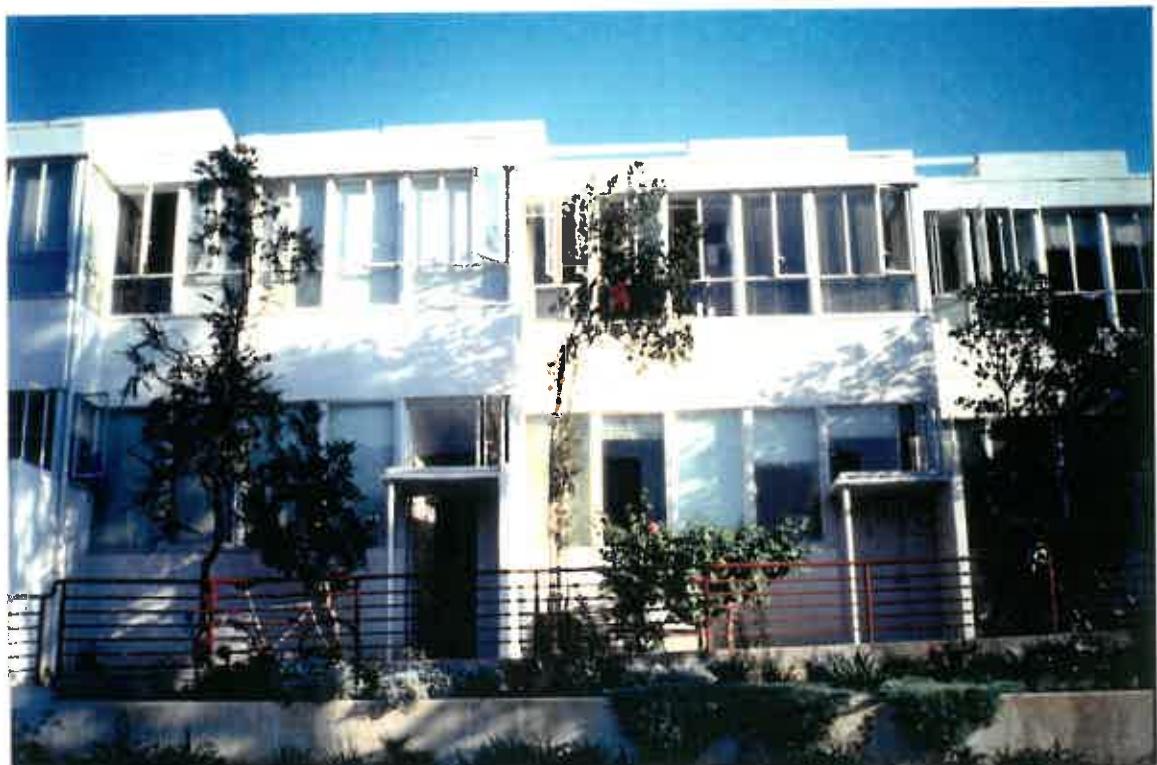
LANDFAIR HOUSES
UCLA
Los Angeles
California

Richard Neutra's row houses (1937) illustrate the architectural model created by the modern movement; (horizontal windows, modern materials). To achieve this image the architect had to use substitute materials from the traditional californian craftsmanship (wood structure with plaster finish to imitate a concrete wall).

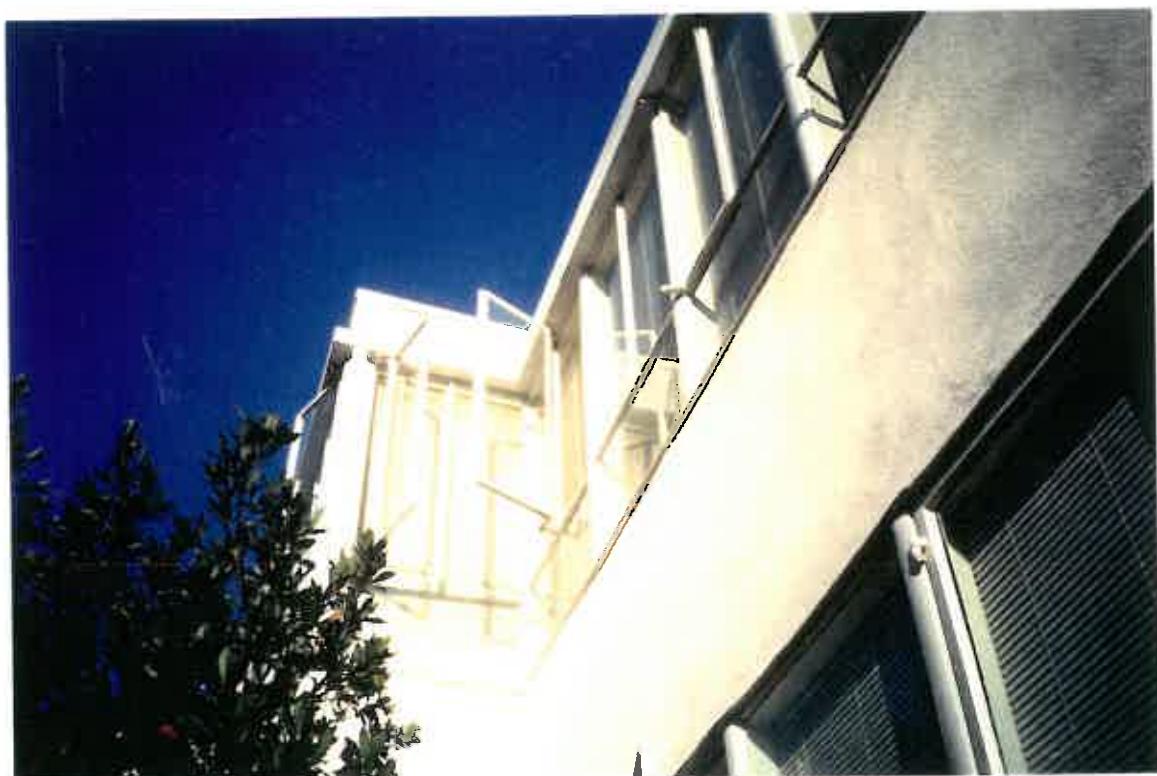
as well as poorly worked stucco details that have become water damaged. Considerations such as these, coupled with the need for earthquake reinforcement and upgrading to fire and safety codes, have caused the restoration process to proceed slowly.

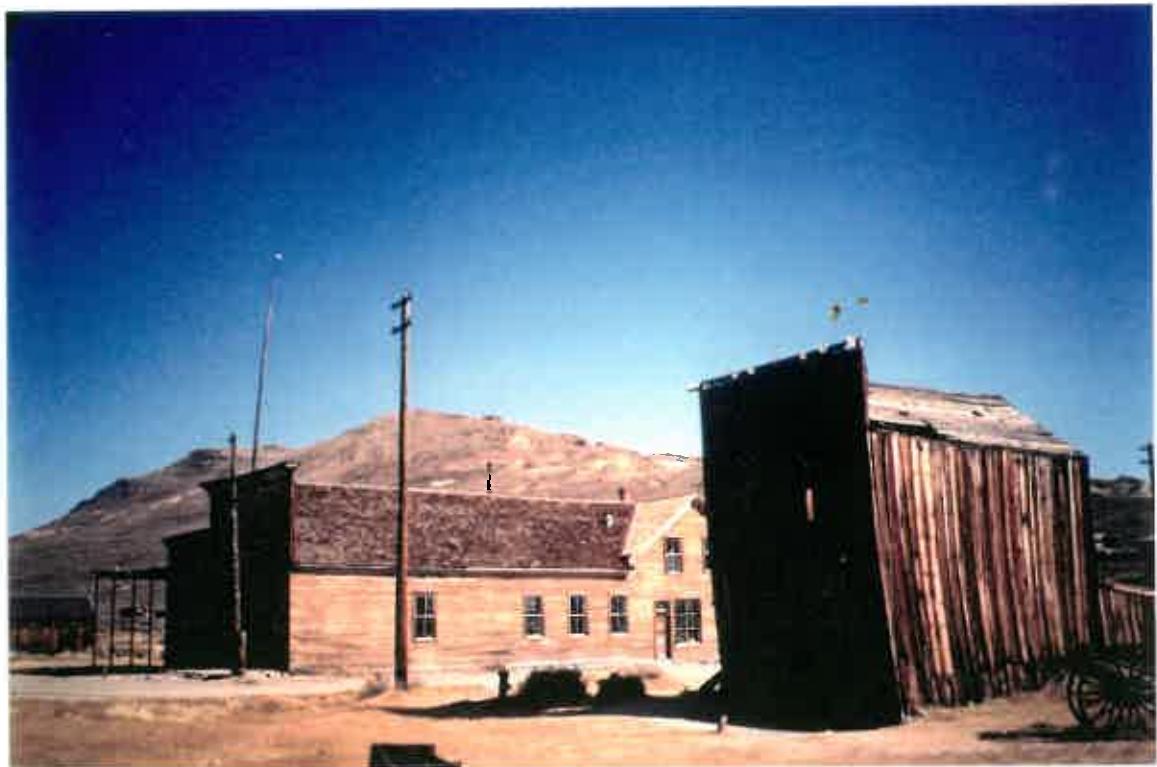
Main structures along Market st. in front of the gold mine.
Comparison of a restored and an unrestored building (building 53).
