THE RICHARD MORRIS HUNT FELLOWSHIP

**RICHARD MORRIS HUNT
FELLOWSHIP
1991**

Pierre-Antoine GATIER
Architecte en Chef des Monuments Historiques

The year 1991 marked the second annual exchange for the Richard Morris Hunt Fellowship between France and the United States. The Fellowship supports an exchange for historic preservation architects to facilitate a mutual understanding of preservation activities between the countries. Sponsored by the Friends of Vieilles Maisons Francaises and the American Architectural Foundation, the Fellowship provides a grant and programmed activities for the selected Fellow. Each year the Fellows alternate, and the 1991 exchange sponsored a French candidate who embarked on a study tour of the United States. The six month program began in July of 1991 and was completed in December of the same year.

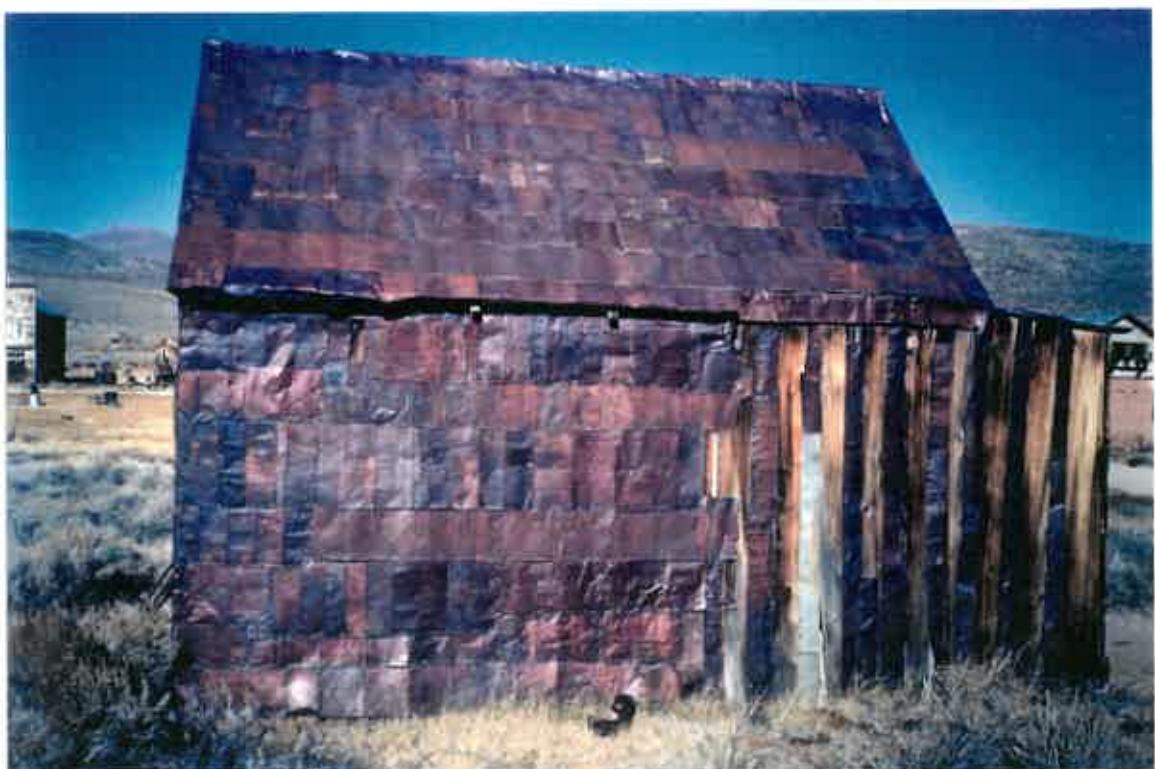
Secondary structure with a wood plank siding over a balloon frame structure recovered with tinplate sheets of metal.

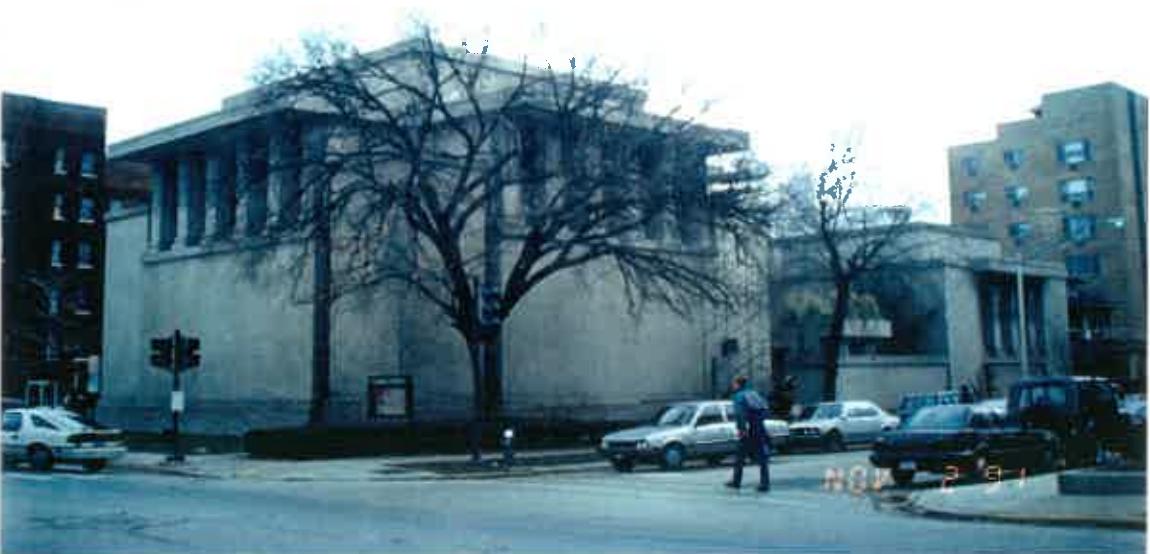
UNITY TEMPLE
Oak park, Chicago
Illinois

Unity Temple (1905-F. L. Wright) illustrates F. L. Wright's division of a structure within two volumes. Its concrete facade was gunned during the 1960's restoration, losing the original finishes and the horizontal form prints

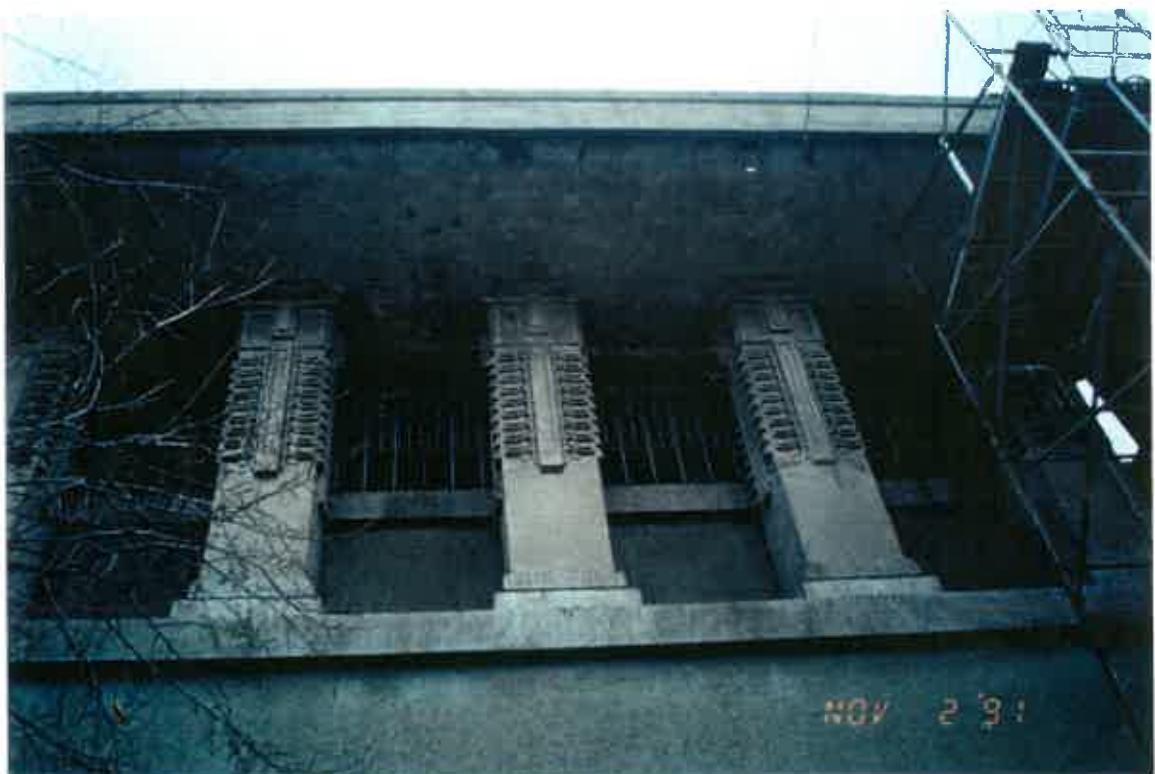
Stiff concrete was placed in six inch lifts, up to eighteen inches each day. Then, the forms were removed and the surfacing was treated to expose the pea gravel aggregate.

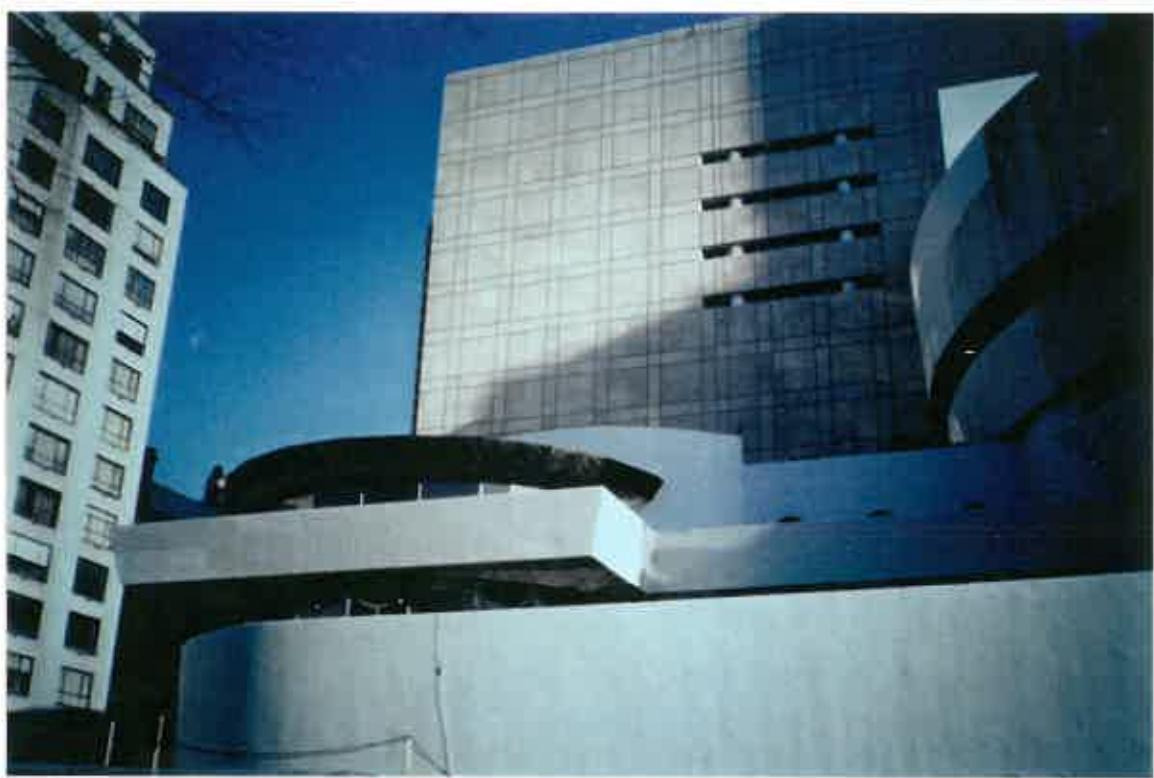
The new addition behind the monitor tower (original location for the administration), replacing a Taliesien addition (F.L W's Studio).

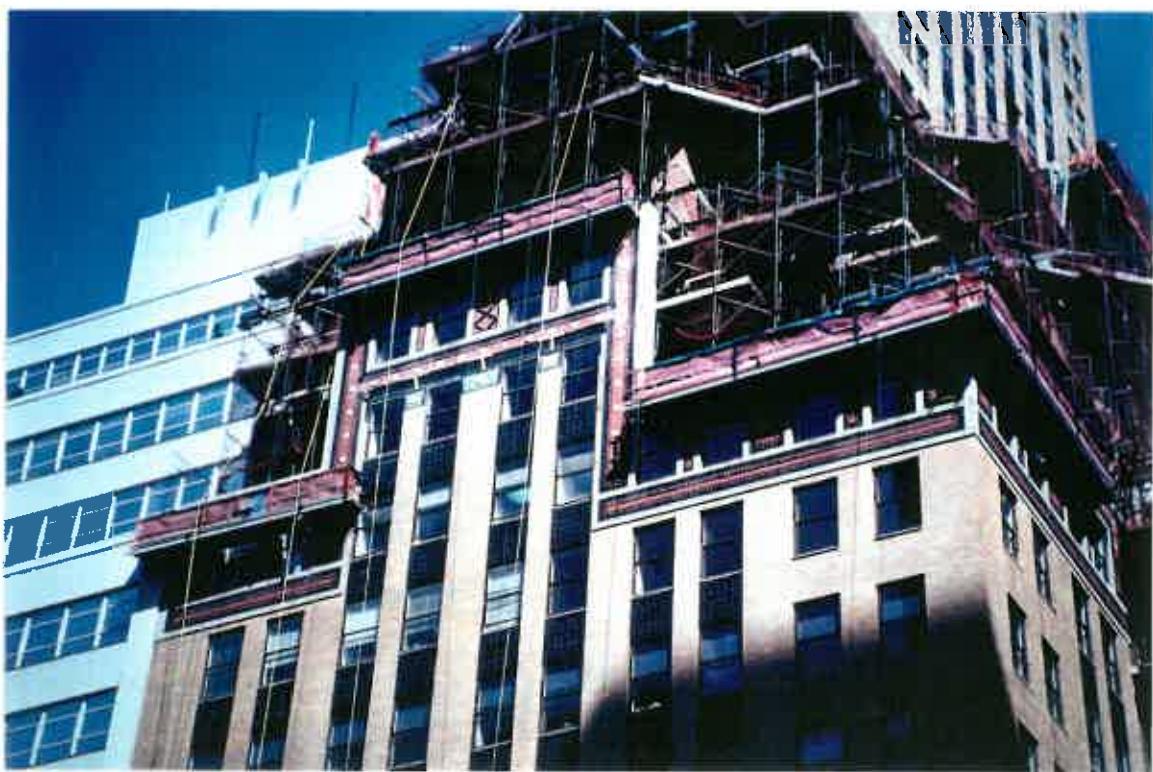
Glazed terra cotta elements decorating the facade along the edges and the window sills.

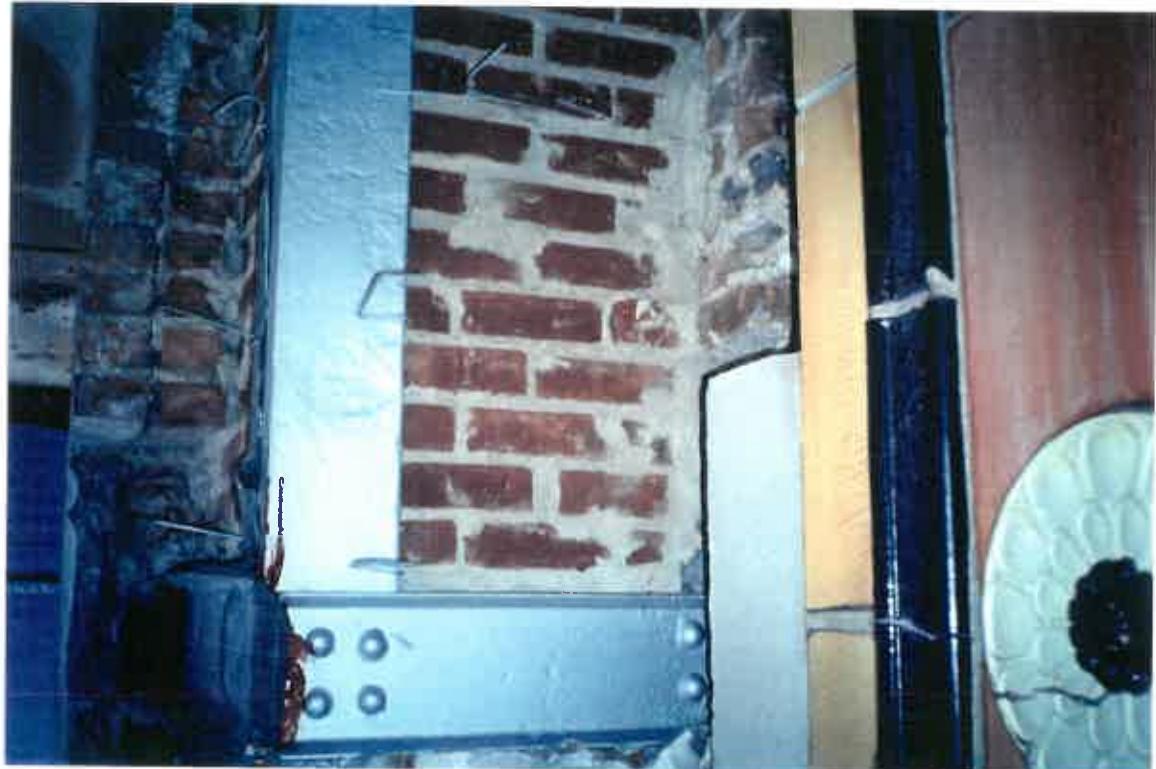
Detail of the wall structure showing the glazed terra cotta veneer hooked to the metal structure and the brick bearing wall.

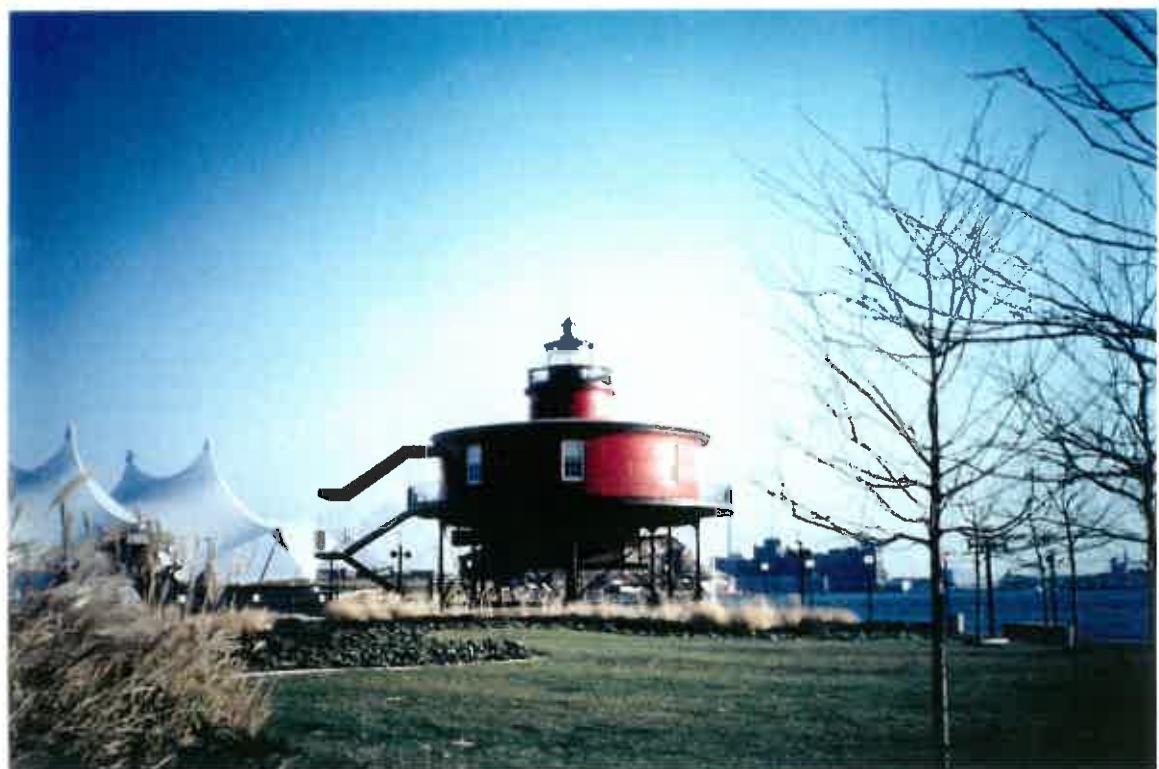
A Chesapeake bay light house (screwed piles) moved from the bay to the water front as a part of its redevelopment.

Exemple of a successful adapted reuse (visitor center)

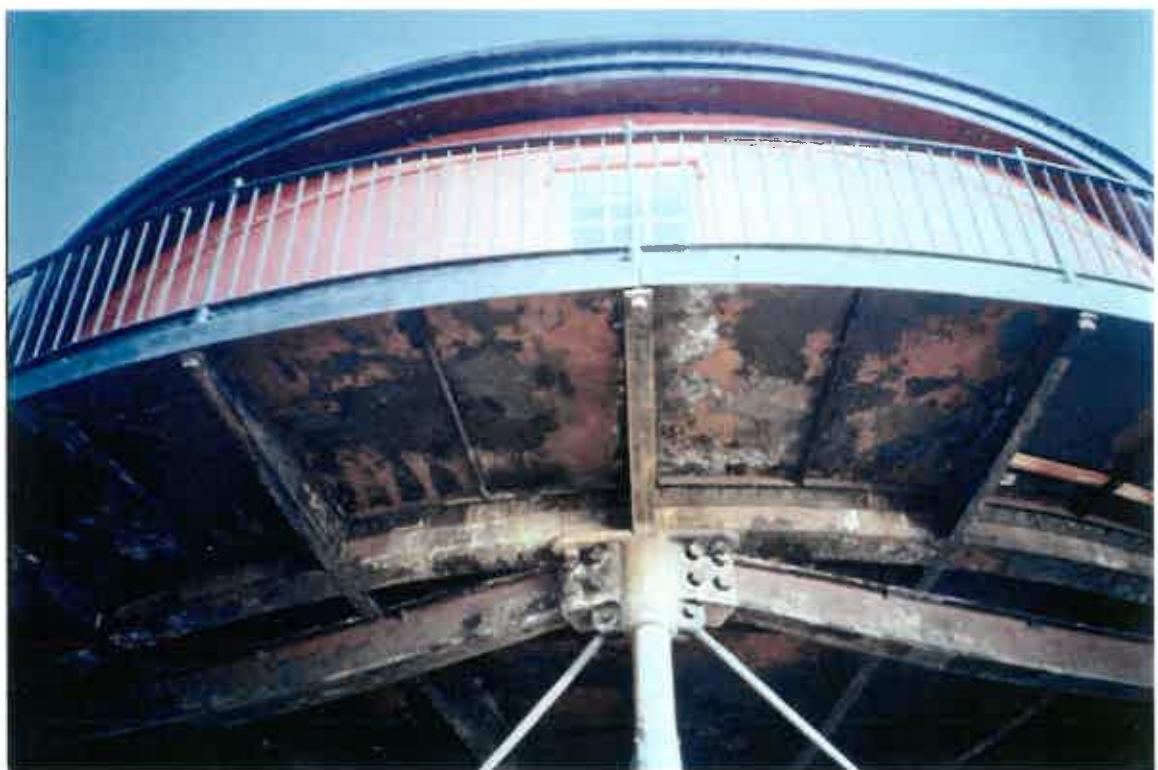
Cast iron columns and beams sustaining the floor slab and the light house.

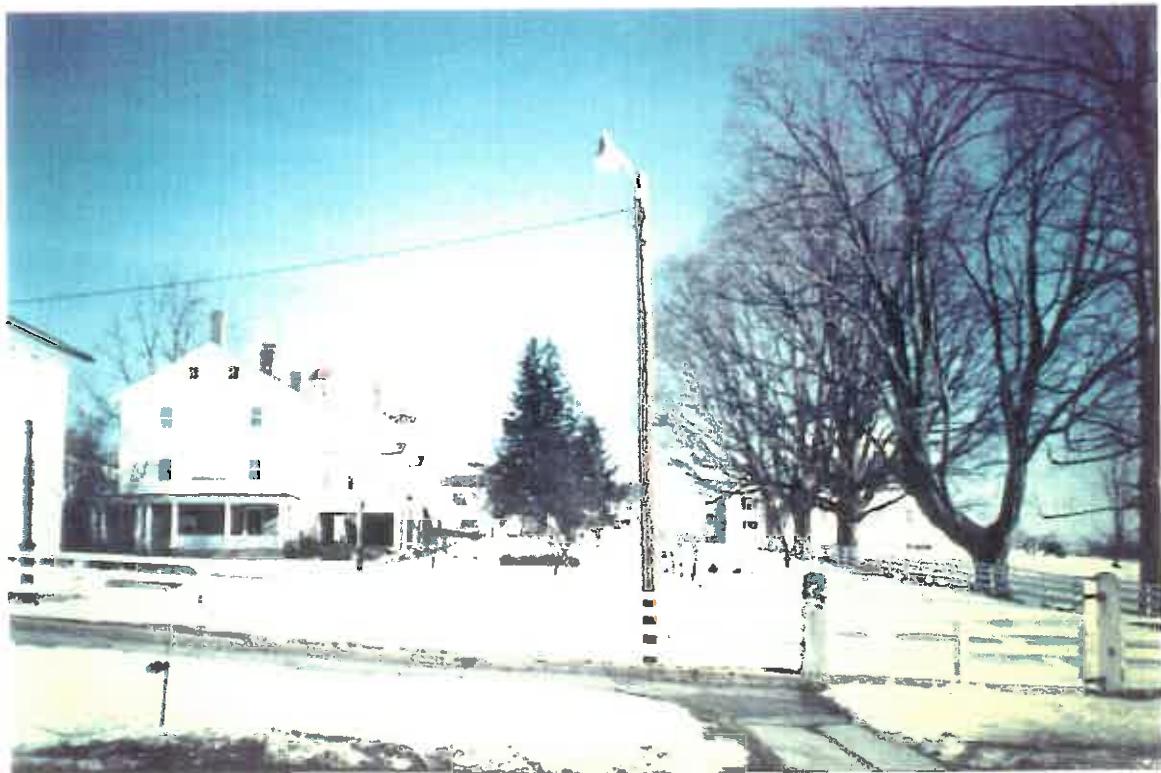
CANTERBURY SHAKER VILLAGE
New Hampshire

Wiew of the village showing its urban organization with four rows of buildings, each one with its own function and connected with the turn-pike. On the left the housing buildings, on the right the sacred buildings.

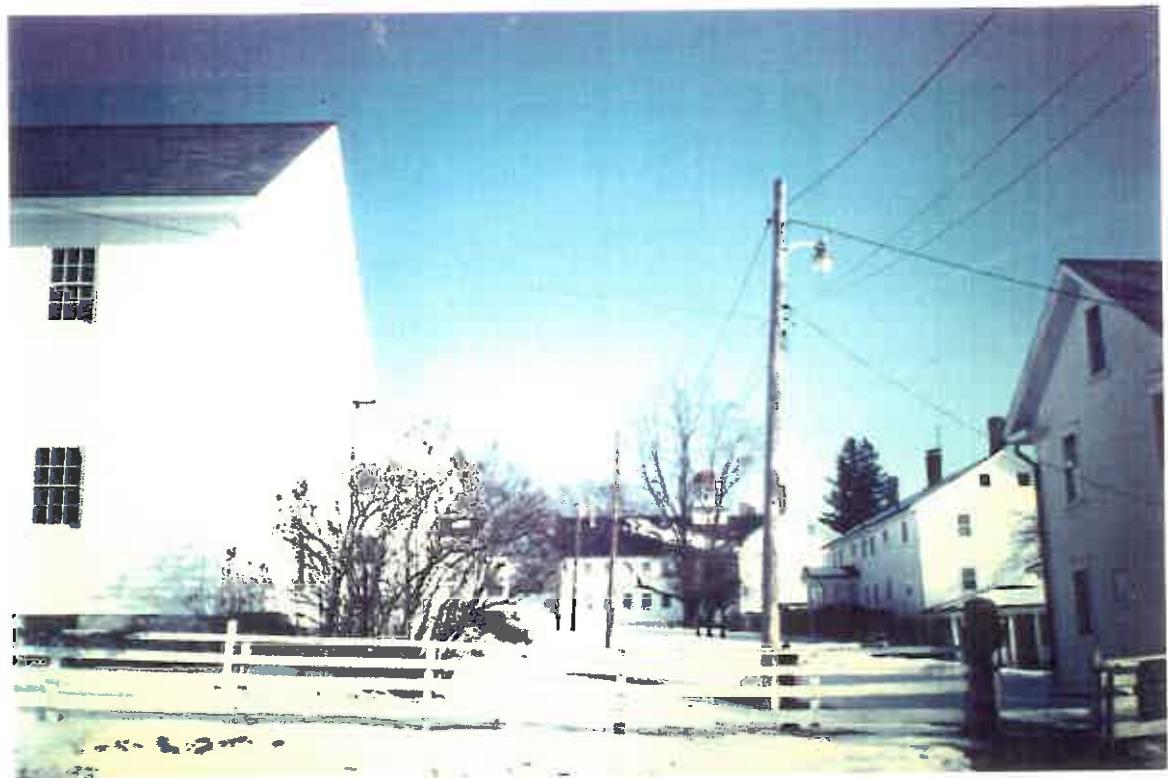
On the left the factory row, on the right the housing row.
