Innovation for Preservation

Conserving Newer Built Heritage in the United States

RMHF Final Report

Vanessa Fernandez

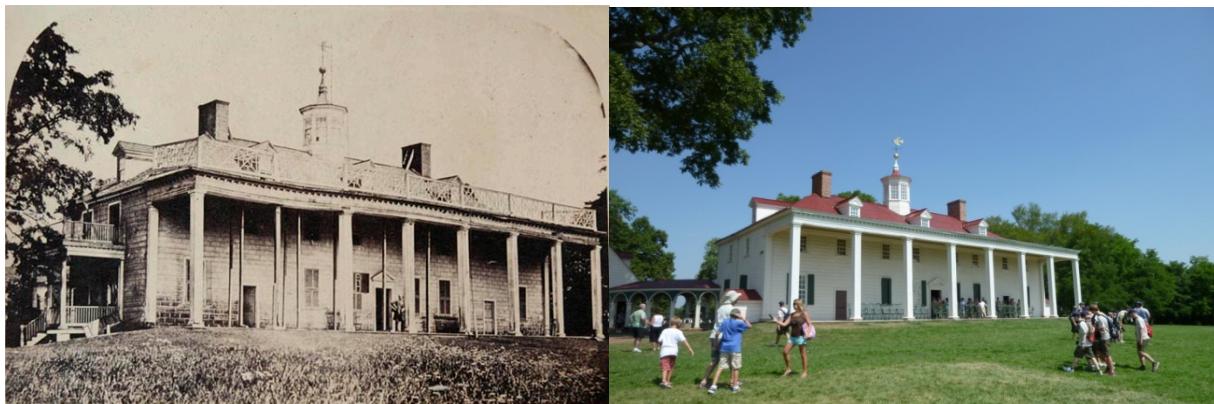
Figure 4: The condition of Mount Vernon at the time of acquisition and its present, restored state. The site receives around one million visitors each year. Sources: (left) Clements Library photographic collections; (right) photograph by the author, July 2010.

When the descendants of George Washington offered to sell the dilapidated, neglected property to the State of Virginia for two-hundred thousand dollars in the mid-19th century, their proposal was rejected. Ann Pamela Cunningham, a woman from genteel South Carolina society then in her thirties, decided that something had to be done to save the historic home of the first president of the United States. She founded the Mount Vernon Ladies' Association in 1853. Through a fundraising campaign promoted by influential women of the time, and in spite of political tensions which would lead to the breakout of the Civil War, they raised the necessary sum to acquire the estate and launched an initial restoration in 1859. This was the first association created for historic preservation in the United States, and it was a citizen initiative.

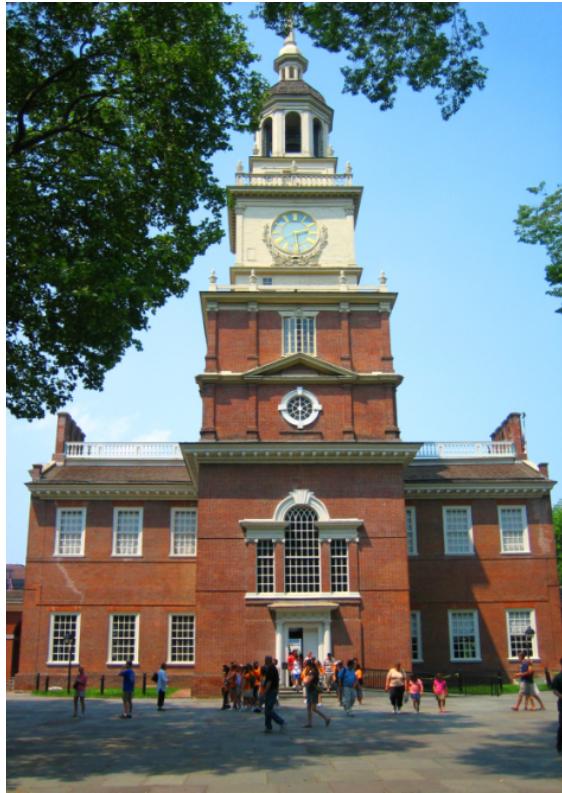
Figure 7: Independence Hall as seen in its context at close range. Author's photo, July 2010.

The contrast between the preserved aspect of the building within its immediate context and the perception of it when seen in perspective from further down the Mall speaks for itself. It is a perfect illustration of the reason so much importance is attached to monitoring construction permits in the periphery of designated or registered historic monuments in France. One observes that two office buildings effectively dominate the perspective of Independence Hall. The building on the right (Penn Mutual Life Insurance Company) is an Art Deco work, while its extension (Mitchell Giurgula Architects)

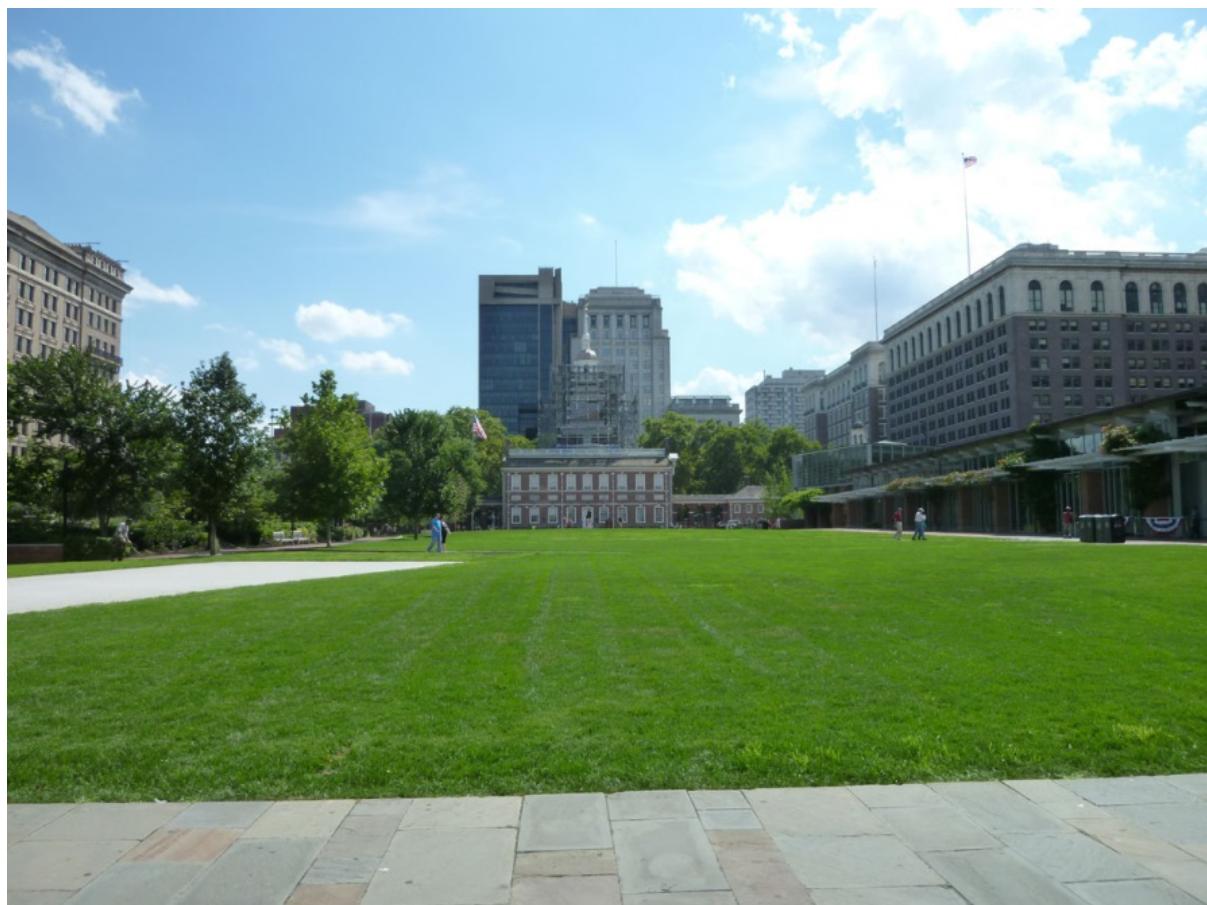
Figure 8: Independence Hall as seen from the Mall. Author's photo, August 2011

dates from 1972, aggressively asserting its modernity in the axis which was created to be historic. If we only look back to the hostile debates provoked by the construction of the Grande Arche de la Défense in Paris, we can understand how negatively a similar project would be perceived in France, if it were possible at all.

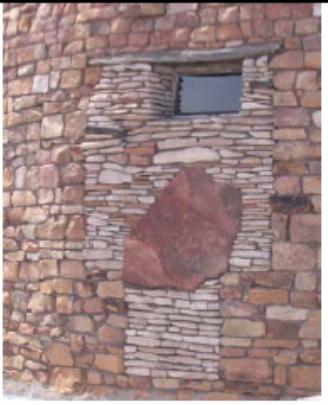
Figure 15: Desert Watch Tower, systematic analysis of elements. Source: NPS / Page & Turnbull Architects

| Element (Description of building element and material) | Historic (Yes or No) | Character-Defining (Primary, Secondary or No) | Conditions, Comments, and Recommendations (Good, Fair or Poor - Provide comments or recommendations) | Images (Photographs) |
|---|---|--|---|---|
| Limestone wall | Yes | Primary | Fair. Thinner stone courses found at upper levels. Several stones protrude past wall surface. Water appears to be infiltrating the veneer. Many of the steel shelf angles are rusted. Many areas of the wall need repointing. | |
| Sandstone wall | Yes | Primary | Fair. Thinner stone courses found at upper levels. Several stones protrude past wall surface. Water appears to be infiltrating the veneer. Many of the steel shelf angles are rusted. Many areas of the wall need repointing. | |
| Petroglyphs, various stone | Yes | Primary | Good. Embedded in limestone wall. | |

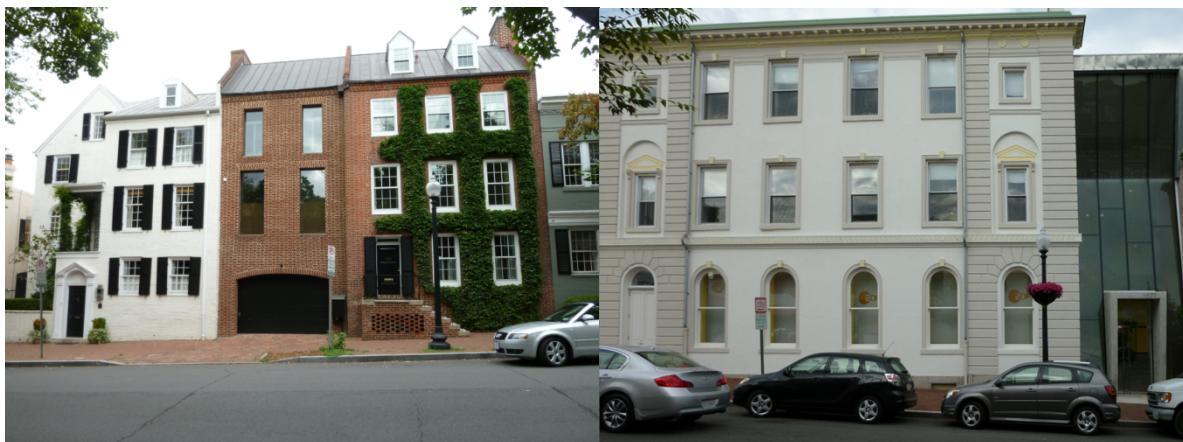
Figure 17: These two contemporary constructions in Georgetown were certainly commented upon by the Commission of Fine Arts. In the first case, a desire for continuity of forms and materials is nonetheless contradicted by the type of windows and the garage door. In the second case the choice of a contemporary addition seems acceptable. Photos by the author, July 2010.

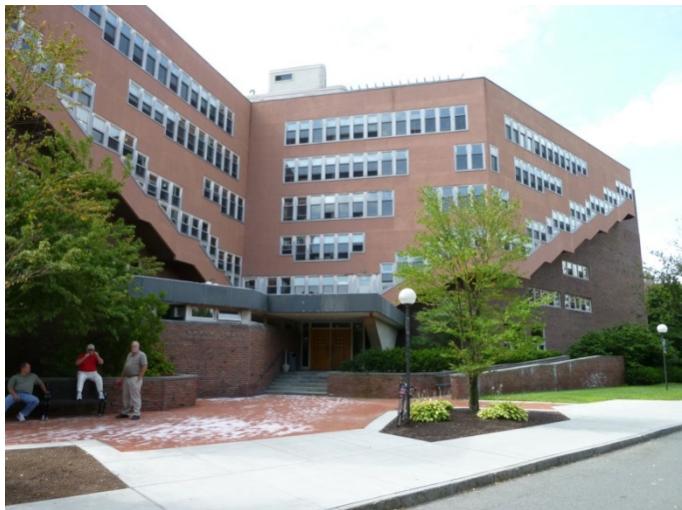
Figure 25: Baker House, Cambridge. The 1998 renovation allowed for the addition of an accessibility ramp by creating a low wall parallel and similar in appearance to the existing retaining wall for plantings, at right. Photo by author, August 2010.

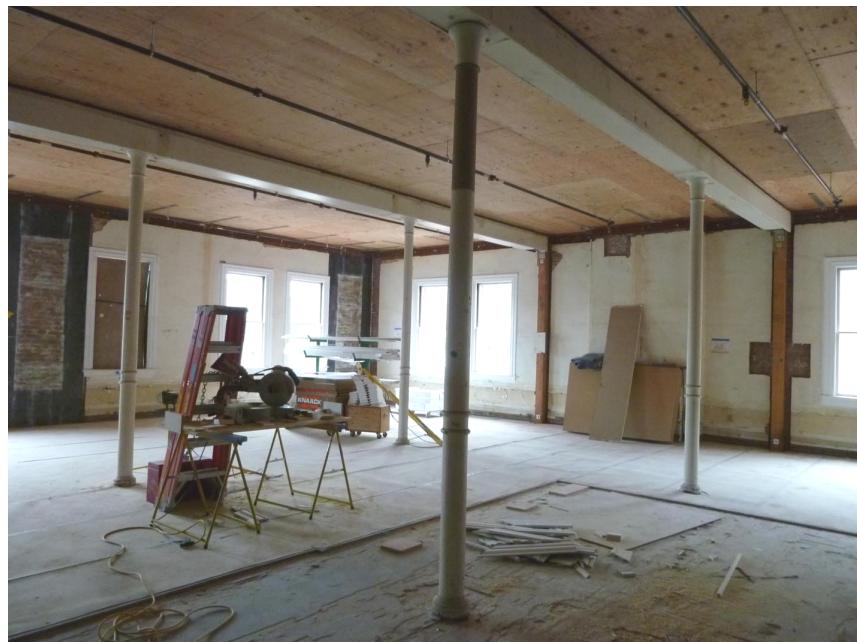
Figure 26: Seismic retrofitting at the Presidio, a traditional structure in San Francisco. The brick panels are chained with carbon-fiber bands to create diaphragm walls. The steel beams surrounding the upper walls recreate a reinforced armature linking the structure with the diaphragm panels. Vertical concrete armatures were also created.

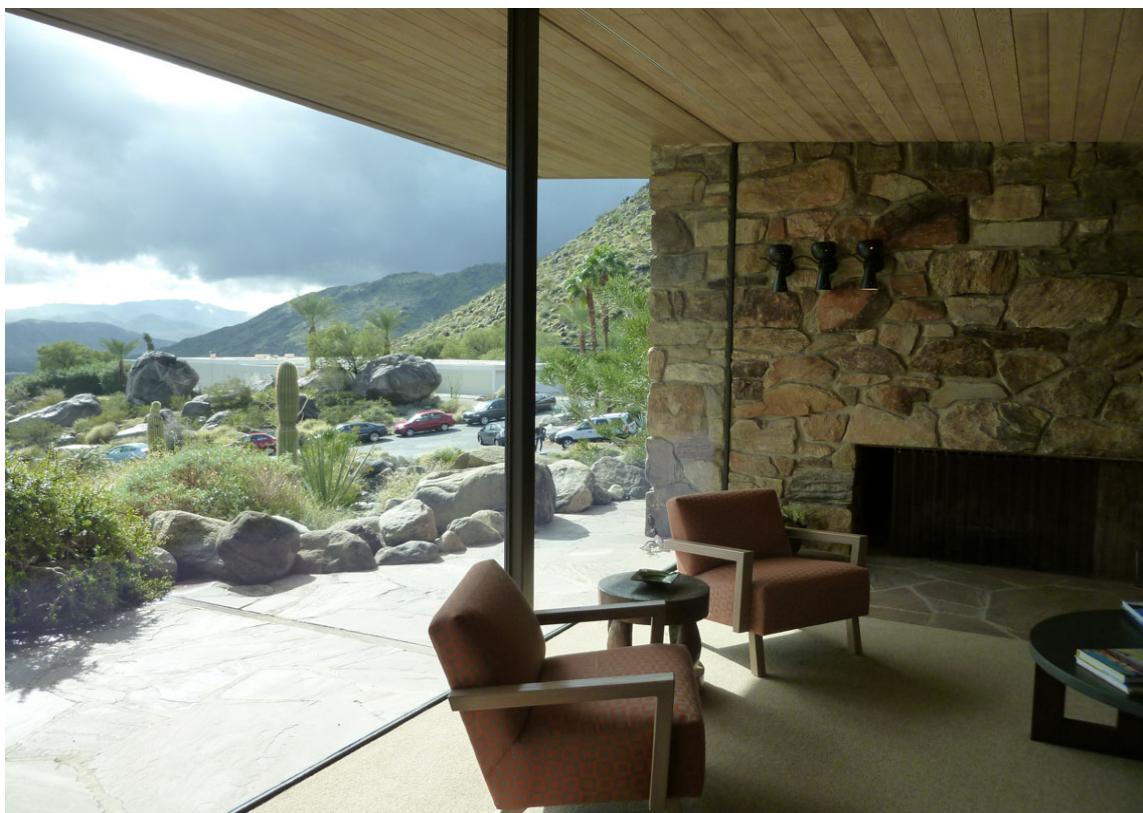
Figure 27: Edris house, Palm Springs

[Figure 27]. Air conditioning installation also led to insulation of the exterior walls whose cladding was replaced with the same material used for the ceilings. The interior and exterior appearance are thus significantly different from the original, but this is the price to pay to meet current standards of comfort and protect the house from depreciating in value. Yet, in my view, the loss of authenticity and material integrity could be said to take away just as much value from the property.

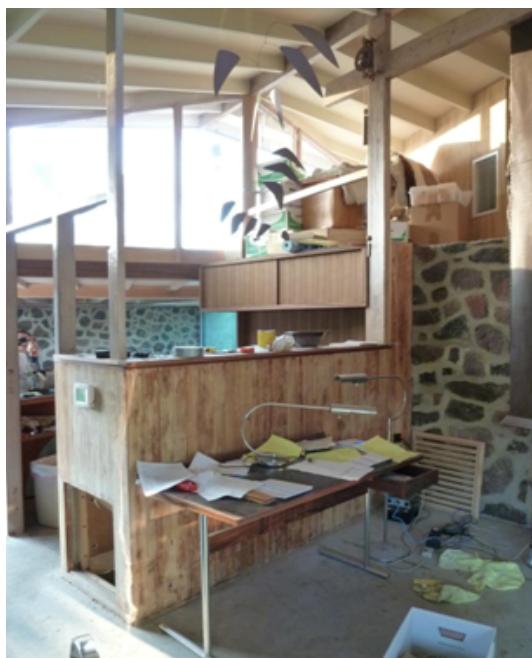
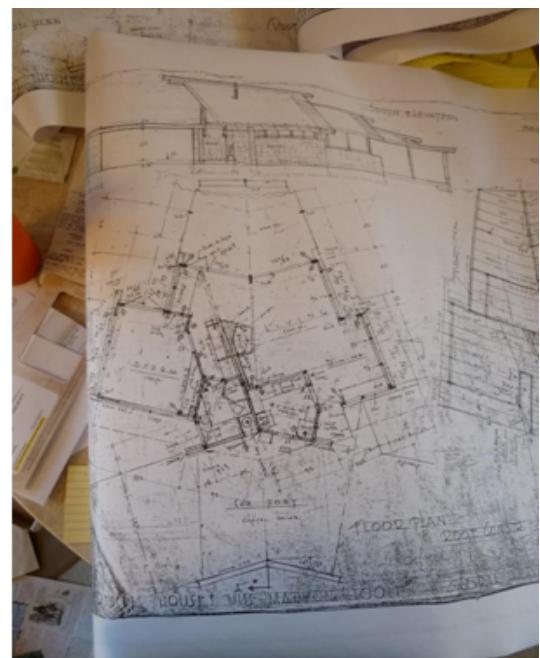
Figure 28: Maryon Tool house, built by Rudolf Schindler at Desert Palm, California, in 1947, restored by the owner according to original plans. The owner had also demolished parts of the original dispositions over a 20-year period but undertook the restoration in view of leaving his daughter an "authentically" reconstituted Schindler house, which has greater value than an altered one. Photos by the author, February 2011

I confronted this issue elsewhere, such as in the case of the renovation of a house built by R. Schindler in the Palm Springs area. The current owner is renovating the house to pass it on to his daughter. Since the structure is not subject to protections, he has total freedom to carry out the work as he pleases. Nonetheless, he engaged an architect in order to avoid making errors,¹¹³ he acquired the original drawings from the Schindler archives and is trying as best he can to follow them [Figure 28].

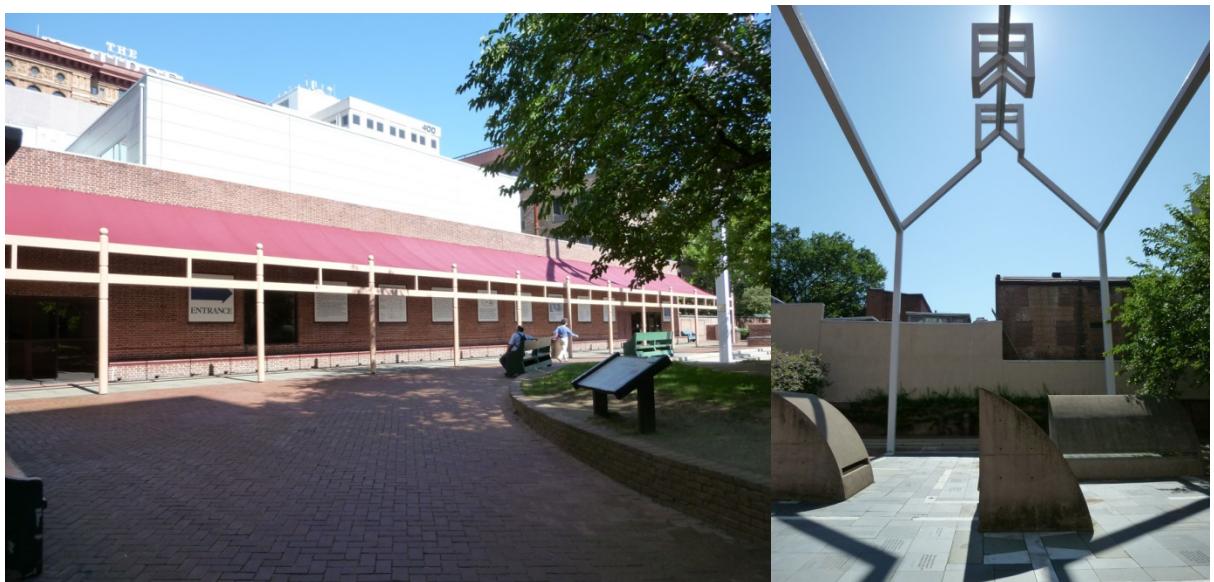
Figure 34: Original entry façade of the Franklin Court Museum (left). Access to the underground exhibition hall is by way of ramp situated behind the wall. The "Ghost House" evokes the historic structure demolished in the 19th century (right). Photos by the author, July 2010

more successful examples. The Ghost House represents Benjamin Franklin's home, demolished in the 19th century, in the form of a metal sculpture [Figure 34]. The evidence used as a basis for the reconstitution are mentioned: texts, extracts of letters, and archeological vestiges are displayed on the floor.

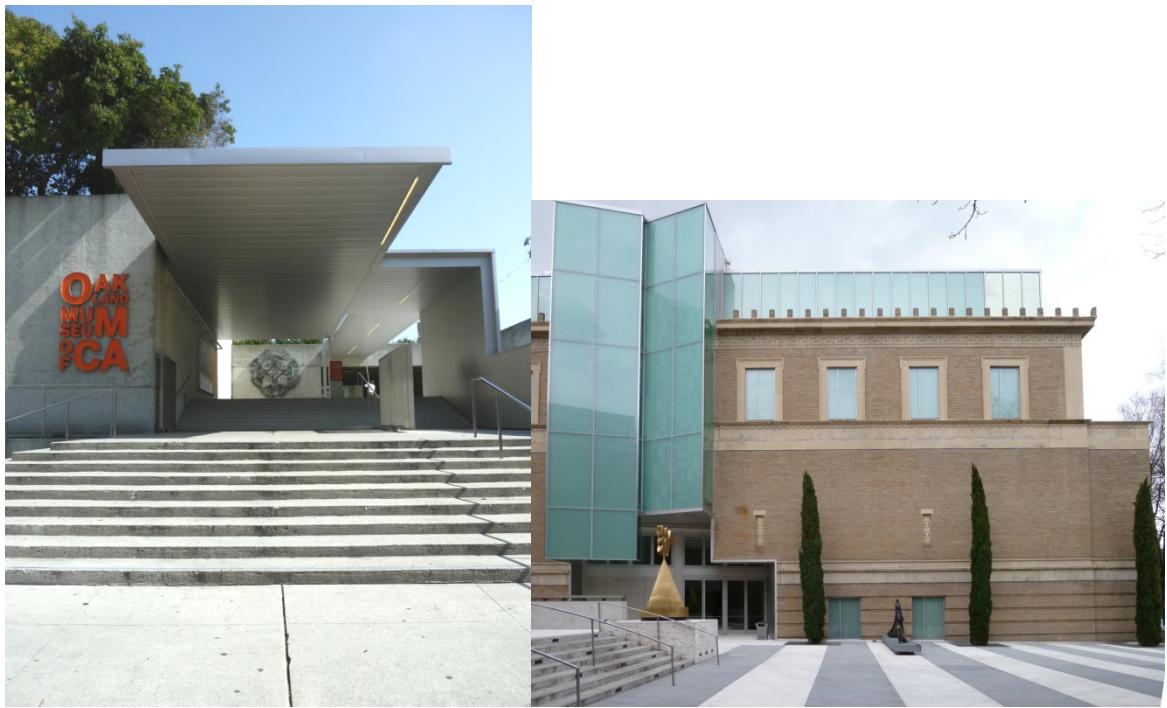
Figure 35: Museums in Oakland and Portland. Two examples of contemporary alterations to existing buildings recognized as local historic landmarks. Left, the Oakland Museum by K. Roche (1970), renovated by Mark Cavagnero, architect, in 2008. The minimalistic intervention is differentiated from the existing building by its stainless-steel placed in interaction with the raw concrete. At right, the Portland Art Museum. The group of three buildings by Pietro Belluschi (1932, 1939, 1978) was enlarged through the conversion of a former Masonic lodge building by the Boston architecture firm specializing in historic contexts, Ann Beha Architects, in 2005. Photos by the author, February and March 2011.

sions using very simple volumes covered in stainless steel which supplant the unused former patios. Stainless steel is also used for the additions on the interior of the museum, such as the ticket booth. This intervention offered a solution for the handicapped accessibility. Finally, contemporary-style signage was installed, giving a youthful air to the somewhat old-fashioned museum. Here, the choice was made to use elements from the vocabulary of contemporary architecture, without resorting to a pastiche or to literal references. Brutalist architecture receives this type of stratification with more success than Postmodernist works as in the previous example [Figure 35]. I must mention another museum extension project I found just as interesting, the Portland Museum of Art (Oregon) by Ann Beha Architects. While the original building is older than the one in Oakland, the glass makes a clear contrast [Figure 35]. The interior space was imagined in order to adapt not only to the historic construction in which it is inserted, but also the P. Belluschi building from the 1950s to which it serves as an extension. The use of different flooring materials is particularly well imagined; it underscores the boundaries and articulations between the different parts of the ensemble.

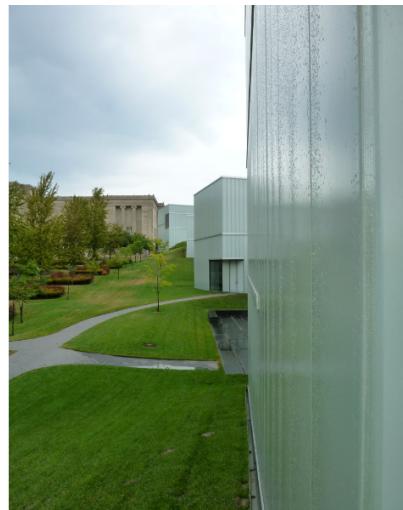
Figure 37: Extension of the Atkins Museum in Kansas City

The architect Steven Holl designed the extension to the museum in Kansas City [Figure 37]. The existence of a vast, Dan Kiley-designed park allowed for a partially underground extension, its presence signified only by minimalist glass protuberances. I found the quality of this work quite seductive, with a magnificent play of light on the interior. The vocabulary and materials utilized, minimalist and hushed, are in harmony with the stone building. The museum is well received by the city's residents. I went to a reception to raise funds for upkeep of the buildings and to enrich the museum's collections. I understood that promoting quality contemporary architecture in existing museums is crucial. Not only is this a

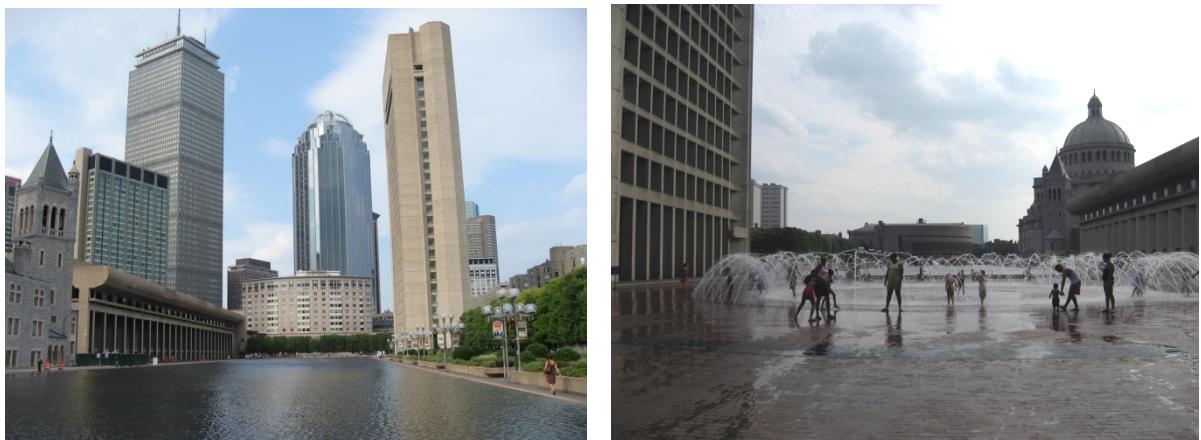
Figure 46: First Church of Christ, Scientist, Boston. Privately-owned space offered for public use. The church has submitted plans for densifying the parcel; registration of the site as a Boston City Landmark has only limited effectiveness in opposition efforts. Photos by the author, August 2010

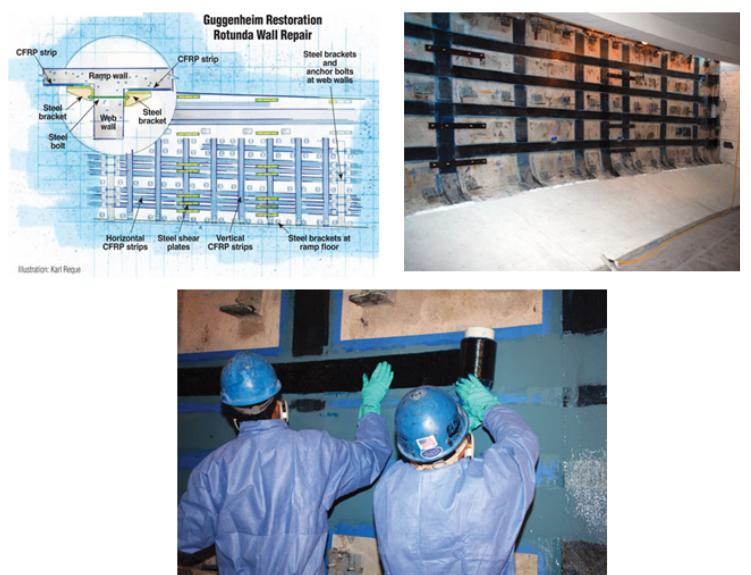
Figure 60: Carbon-fiber reinforcement of the walls of the sixth-floor ramp.

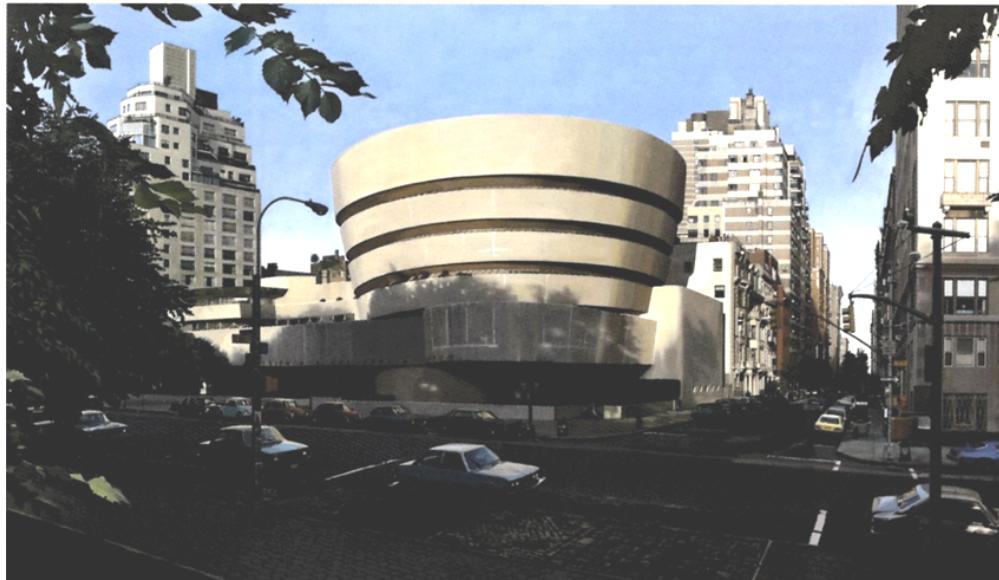
Figure 62: The Guggenheim Museum in the 1970s. Repairs to cracks in the pedestal are clearly visible. Also worth noting, the building's original "Fresh Butter" color

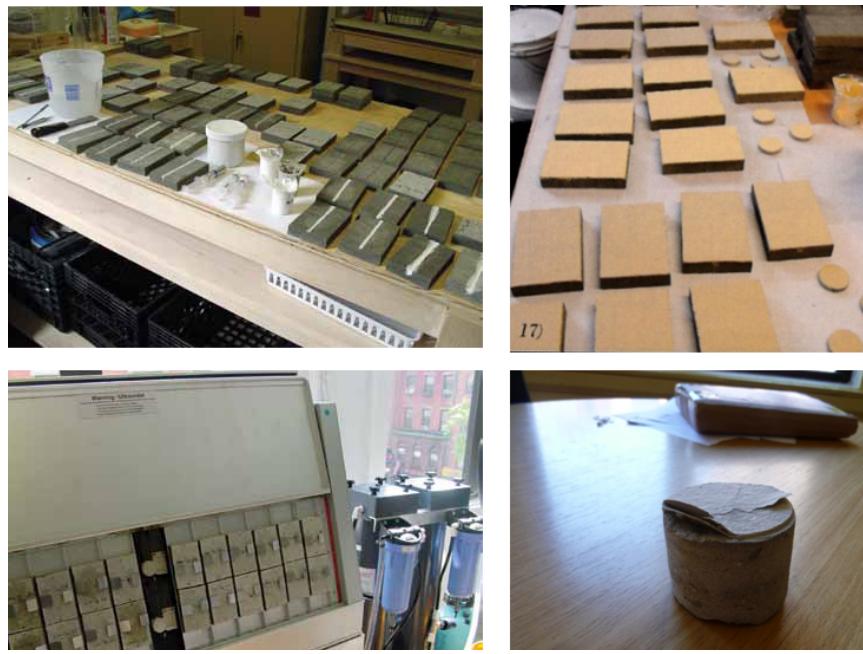
Figure 63: Samples for testing the resistance of filler products and its compatibility with the cladding. The samples are then placed in the QUV (lower right). At right, a drill core from destructive tests on the existing building. Note the number of coats of paint on the cladding

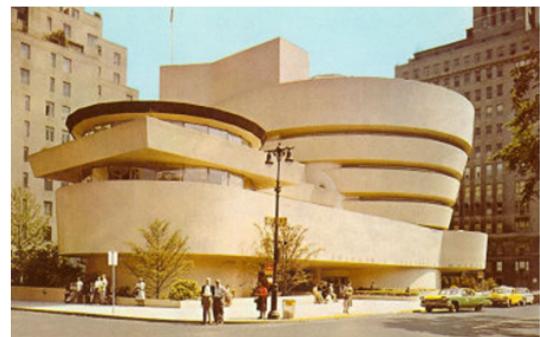
Figure 65: The building in its original color and a sample card of "powell buff" located in archives

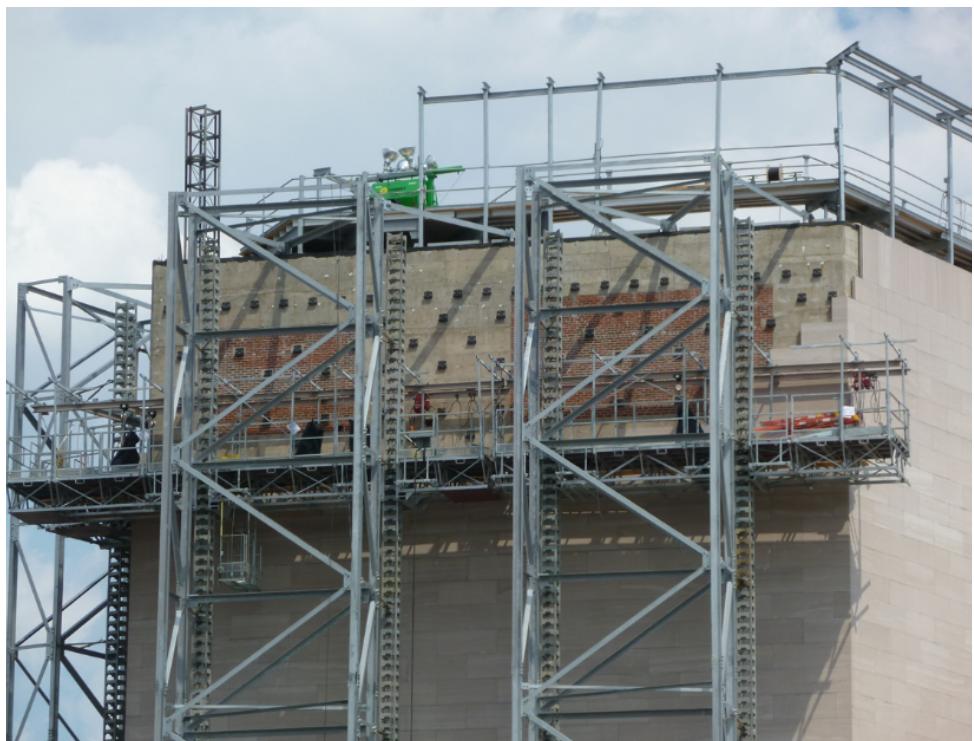
Figure 71: Repairing stone on the façade of the National Gallery of Art, Washington, D.C.

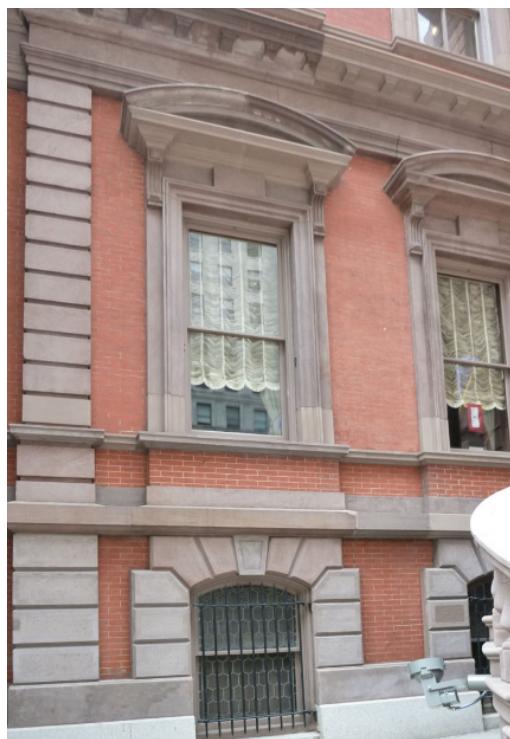
Figure 72: Stone repairs in Philadelphia

Cast stone reinforced with carbon fiber is commonly used to replicate façade stones. In some restorations, fiberglass is used, as in the cases of the Terra Building and Union League Building in Philadelphia. Cast stone can be used to replace stair treads, balustrades, and to do repairs... For high-rise buildings, concrete and stone repairs consist mainly in injecting penetrating sealers, smoothing out surfaces, draining water from slopes, injecting epoxy into cracks, sealing joints and cracks, replacing steel reinforcements and coating them with urethane or epoxy, replacing expansion joints, etc. [Figure 72]

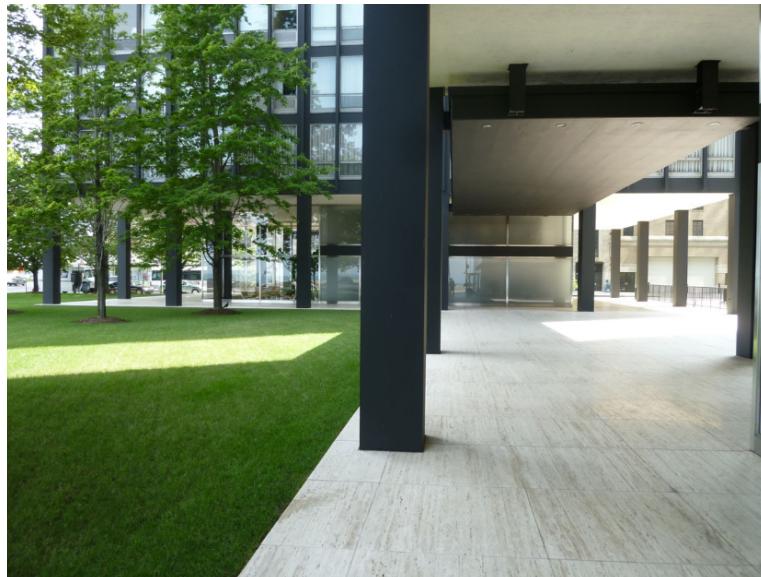
Figure 74: Plaza at Lake Shore Drive

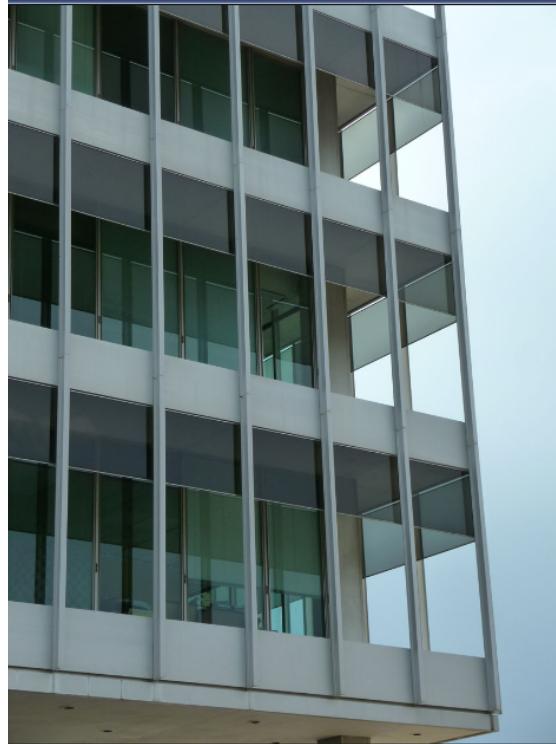
Figure 76: Warren Petroleum Building, Tulsa (today International Plaza)

system on the exterior. I wanted to find out if this protection preserved the original facade elements and whether the interior comfort and the energy expenses were satisfactory. The building, built in Tulsa, Oklahoma, by SOM in the 1960s, is still in operation, and I had the chance to meet members of the building maintenance and management staff. This example helped me to understand the impact of a functioning office building on its mechanical services, especially when the original, unmodified façades are in place [Figure 76].

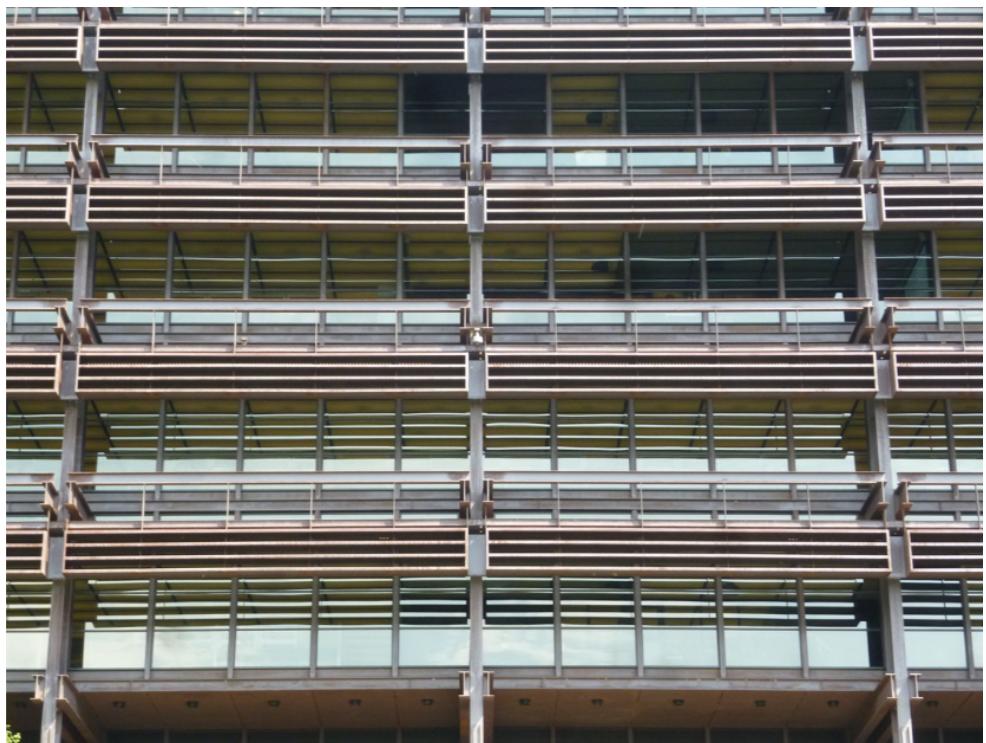
Figure 77: John Deere Headquarters, E. Saarinen, architect

curtains or blinds for the summer, only for the reflection of snow in winter; otherwise there is no need for them. The glass is reflective and the exterior louver-type screens in thick metal protect the façades quite well. Window framing was changed two and a half years ago to incorporate dual-pane glass and thermal barriers [Figure 77]. Since then, 30% has been saved in heating each year and now only one boiler is turned on instead of two. On the other hand, I was unable to learn whether there had been any savings in air conditioning. The original laminated glass has been replaced by dual-pane glazing. The investment has already been recovered through fuel savings.

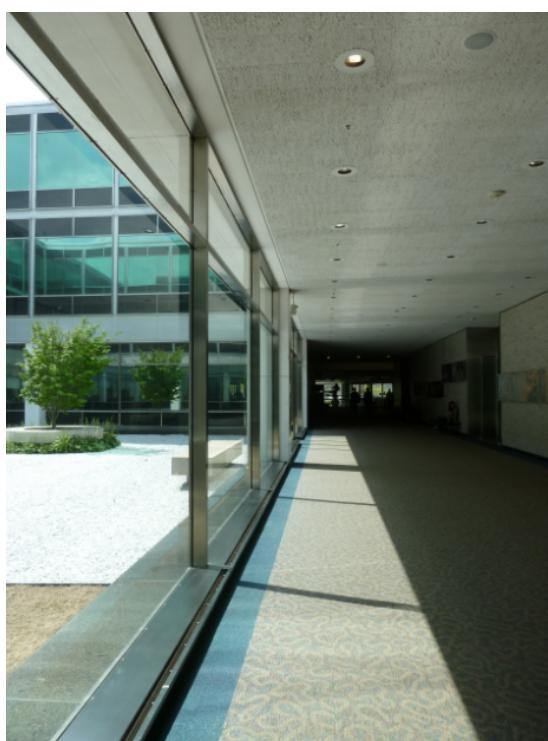
Figure 78: Cigna Building, SOM Architects

This building interested me because it was almost demolished a few years ago but was finally renovated instead. I was received by the building's maintenance managers.¹⁹¹ Today, it serves as the headquarters of a health insurance company [Figure 78]. It was built in the late 1950s by SOM Architects of Hartford, Connecticut. In the late 1970s, an addition was created with exactly the same characteristics as the original 1957 building. Fryer and Associate, an architecture office in Hartford, handled the renovation. About fifteen years ago, the independent electricity generator was removed and had to be extracted from the building, which proved to be complicated task. The generator is now located outside. It produces electricity for the computers – the facility is all-electric – and supplies steam for the kitchen as well. For heating, there are three boilers which were replaced fifteen years ago. All air conditioning is computer-controlled. Pond water was used for the sprinklers and the cooling circuit in the past, but this system has been changed.

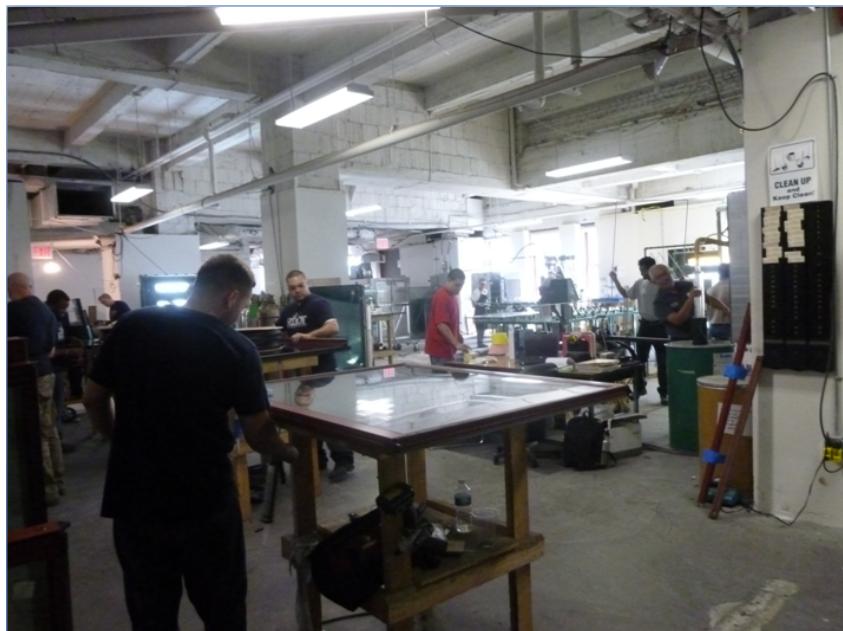
Figure 79: Serious Materials: transformation of the windows of the Empire State Building

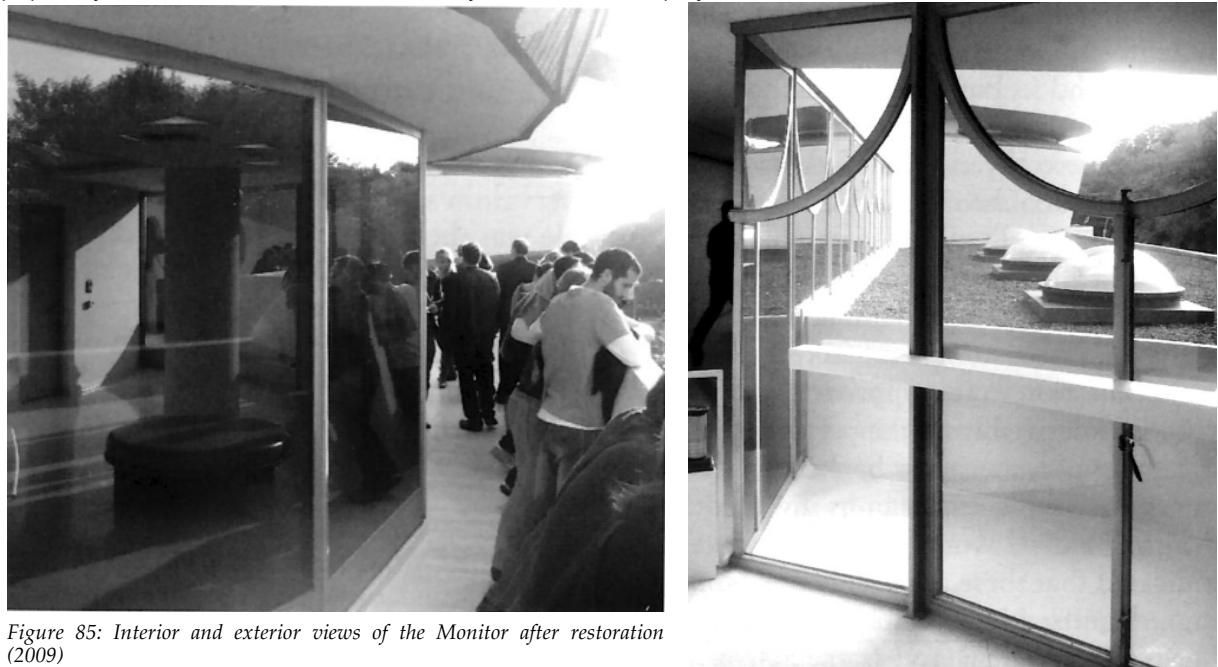
Figure 85: Interior and exterior views of the Monitor after restoration (2009)

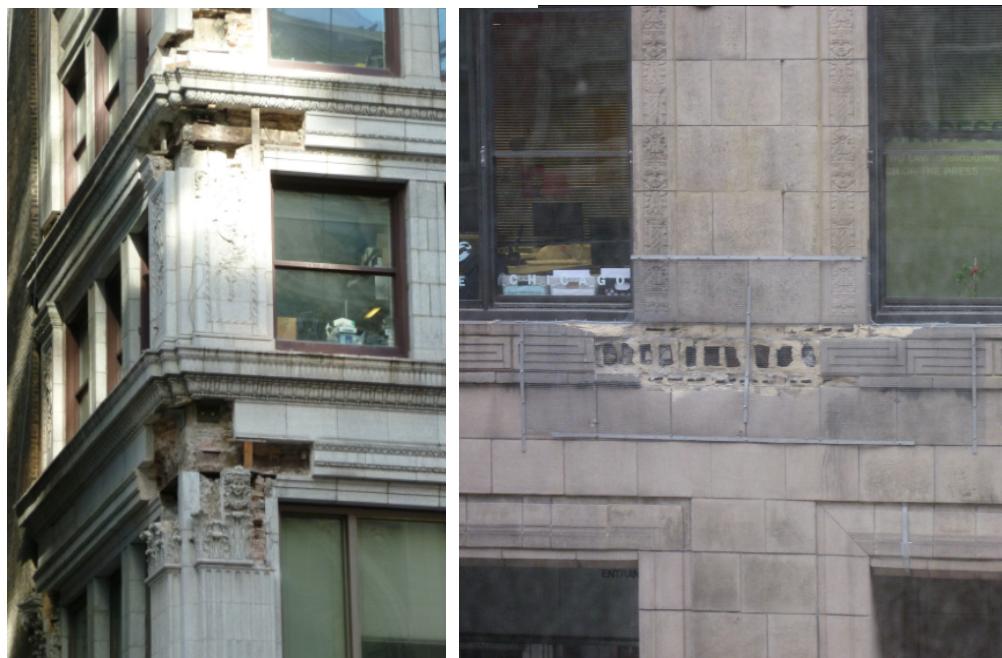
Figure 86: Pathologies affecting terracotta in Chicago. Photos by author, 2011

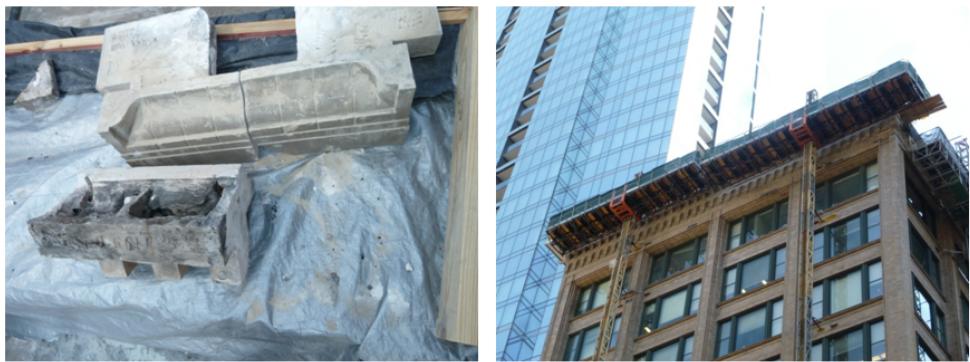
Figure 87: Detail of a terracotta cornice on the renovation worksite at the University of Chicago. Mary Brush, Preservation Architect, Holabird & Root

In cities like Chicago, terracotta-clad façades are frequent. The illustrations [Figure 87] clear-
